# Eesti põhimaanteeede kvaliteedi hindamise ekspertuuring

Road construction quality surveys with  
non-destructive methods on selected sites in Estonia

Annele Matintupa, Tomi Herronen, Anssi Hiekkalahti and Timo Saarenketo

2012

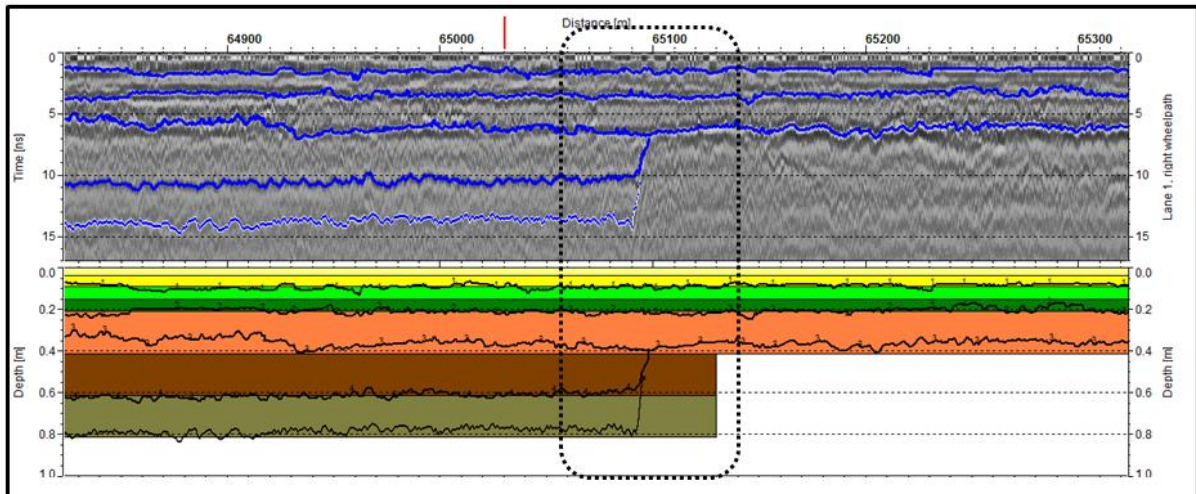
Figure 61\_2. The thicker structure ends earlier than designed. Colour bars represent the design structure and black/blue lines the interpreted structures.

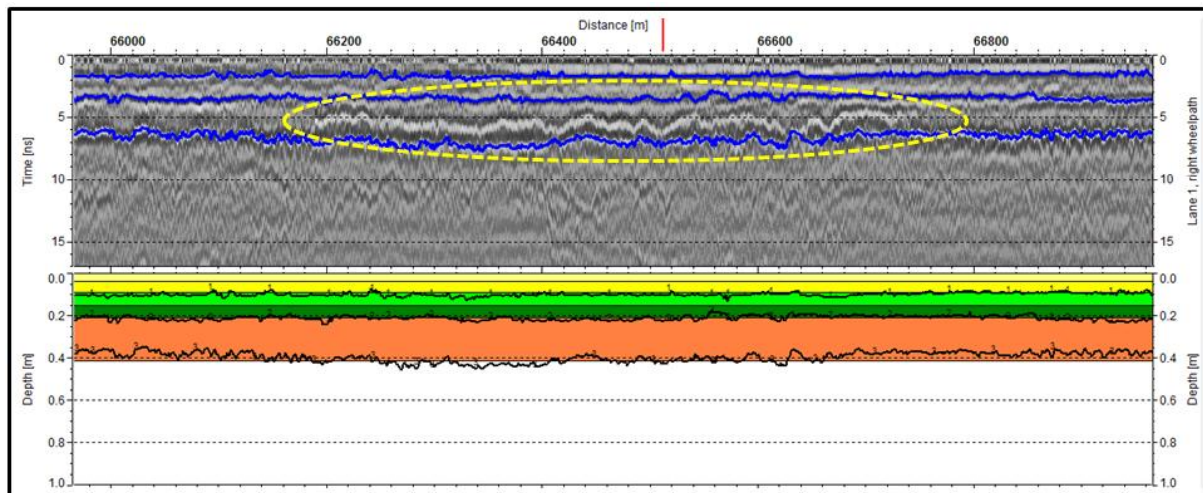
Figure 61\_3. From chainage 66 185m to 66 740m the base course (Graniitkillustik optimaalne segu 0/63) has been built in two parts.

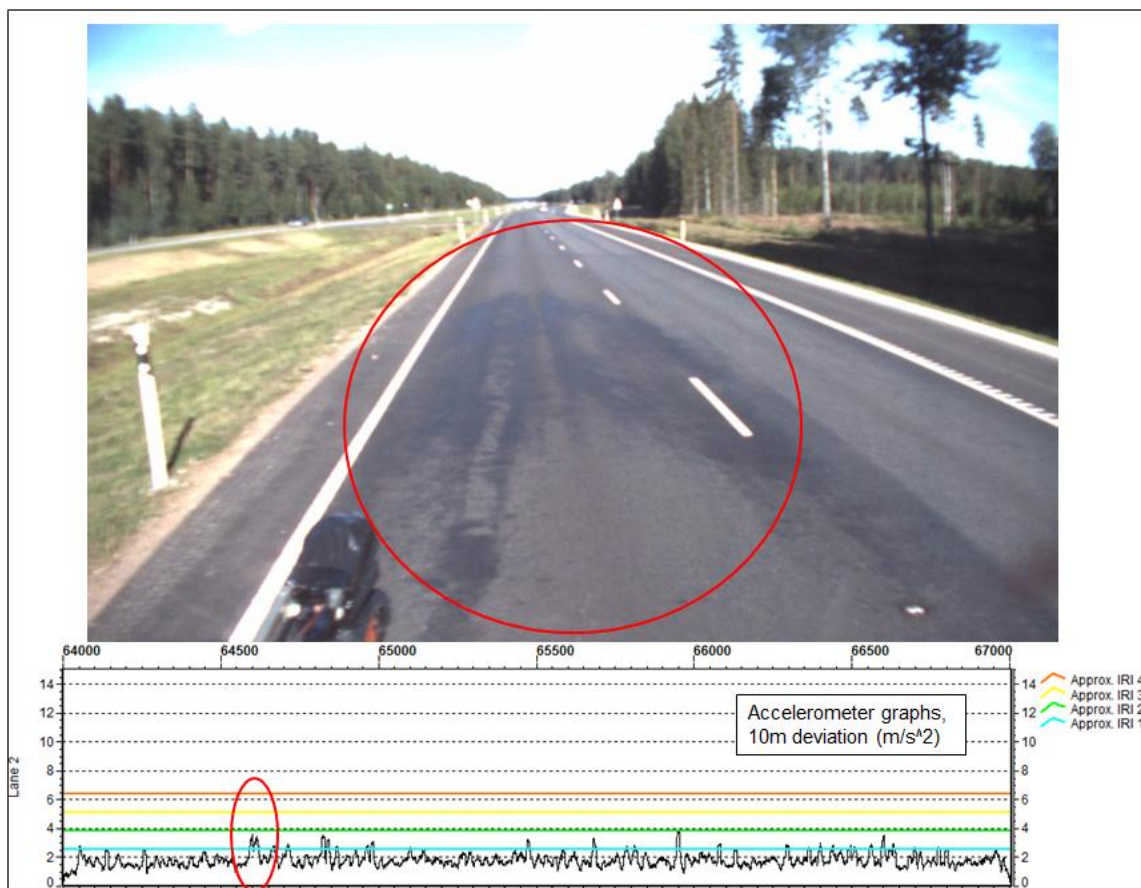
Figure 61\_5. Very small imperfections in lane 2, at chainage 64600m.

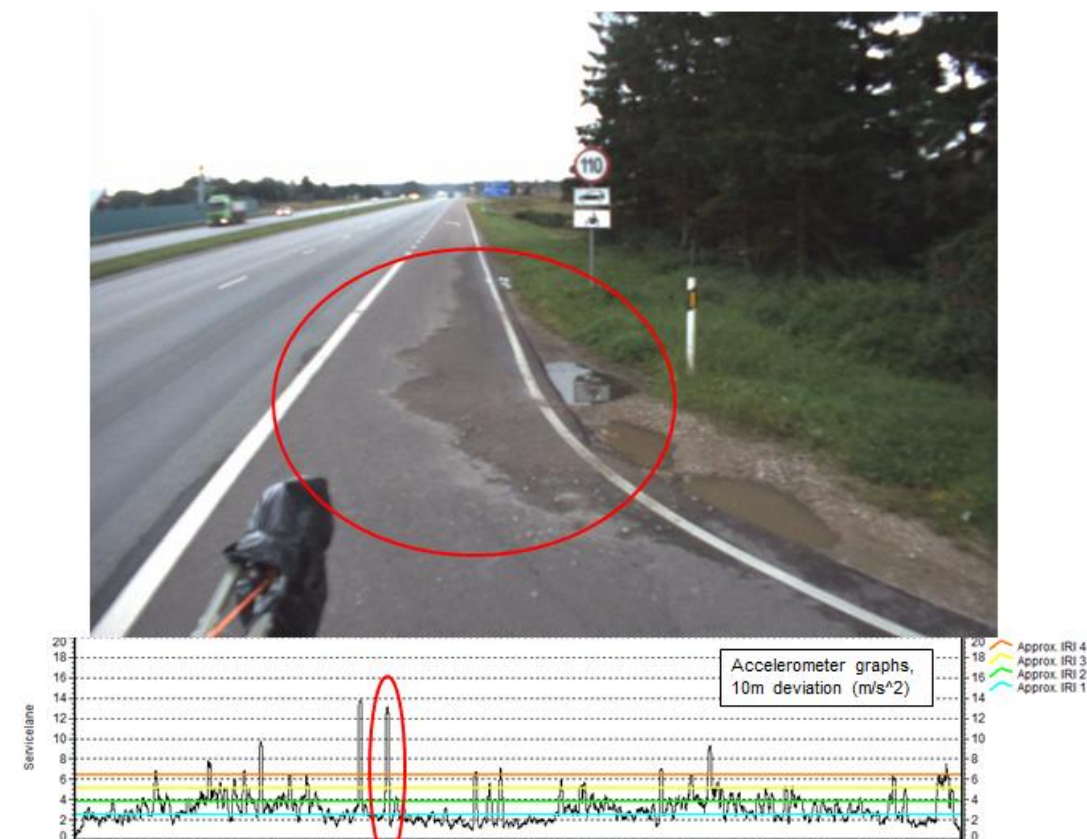
Figure 62\_3. Deformations with standing water (service lane, 23040m)

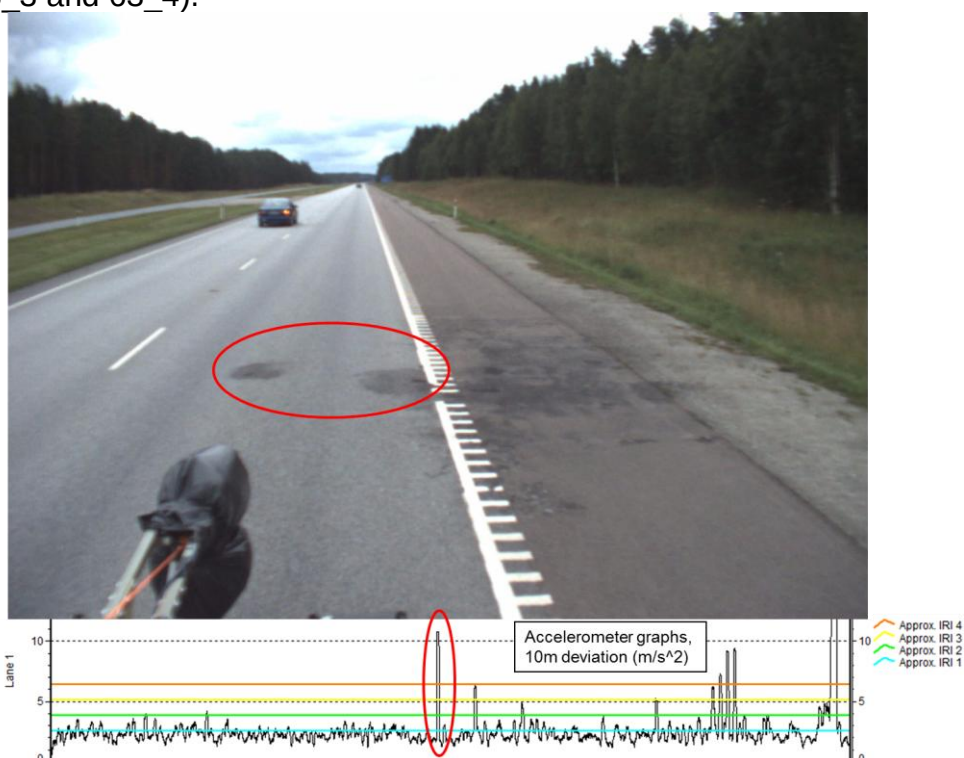
Figure 63\_3. Pavement damage on lane 1 at chainage 43 550m. Perhaps this was caused by a recent crash.

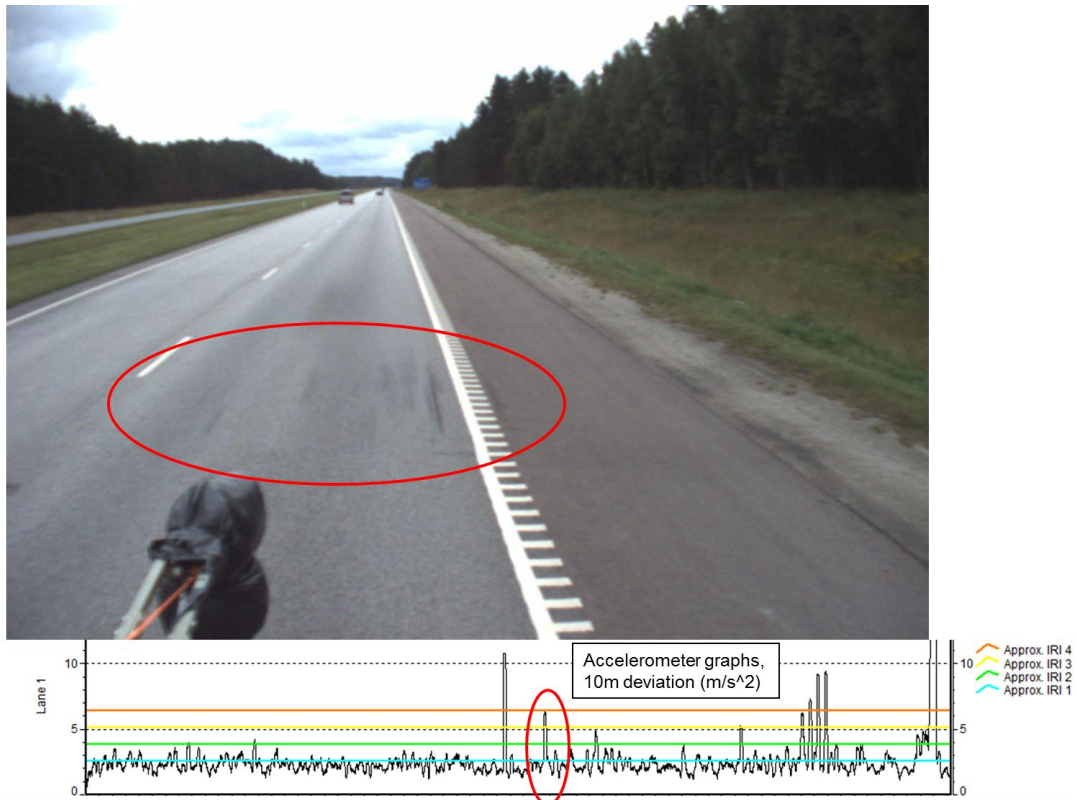
Figure 63\_4. Bump on road surface (related to frost?) in lane 1, at chainage 43 700m.

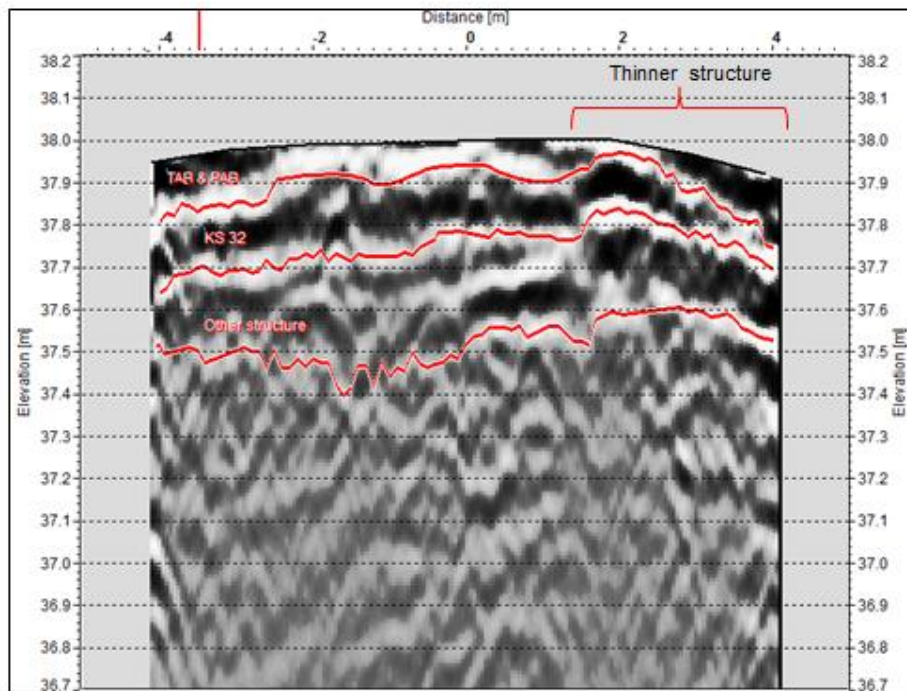
*Figure 64\_1. GPR data of cross section at chainage 84 shows that the road has probably been widened. The total thickness of road structure is thinner on the right side, but instead the bound pavement layers are thicker.*

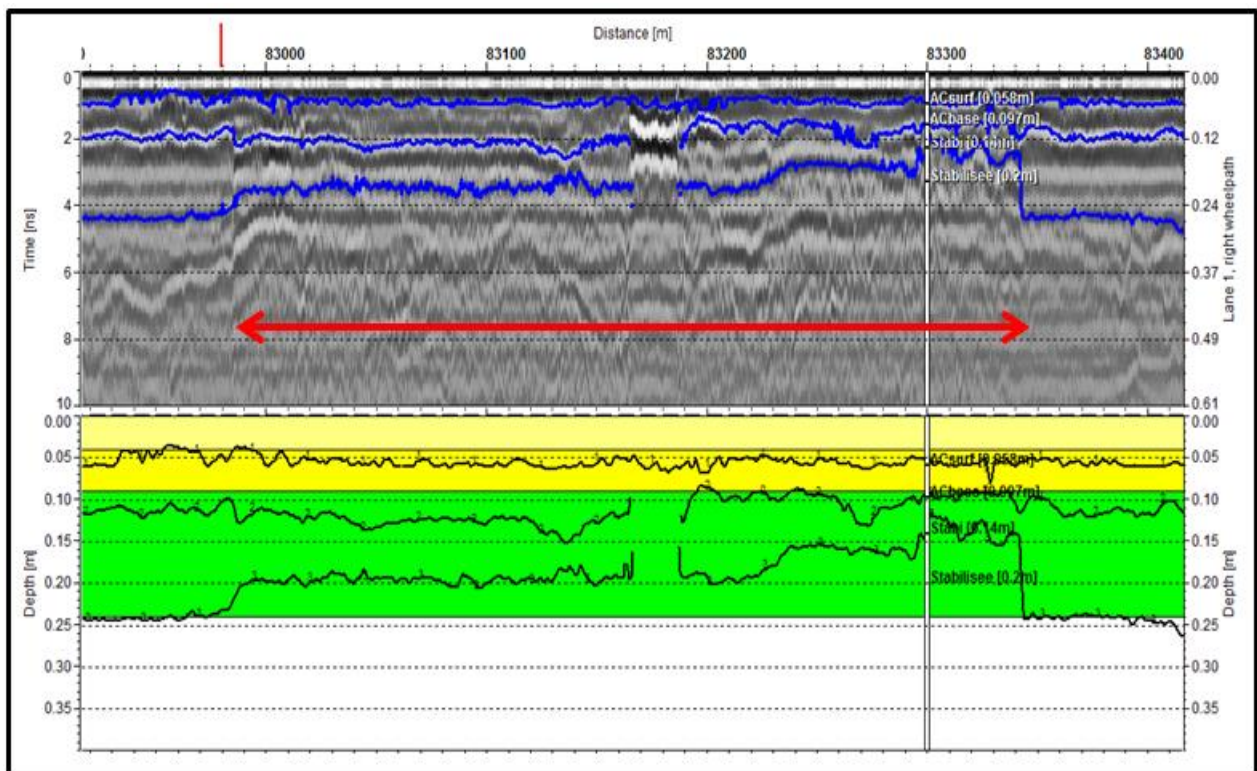
Figure 64\_2. GPR data as longitudinal profile. The area where structure is different around the bridge has been marked with red arrow.

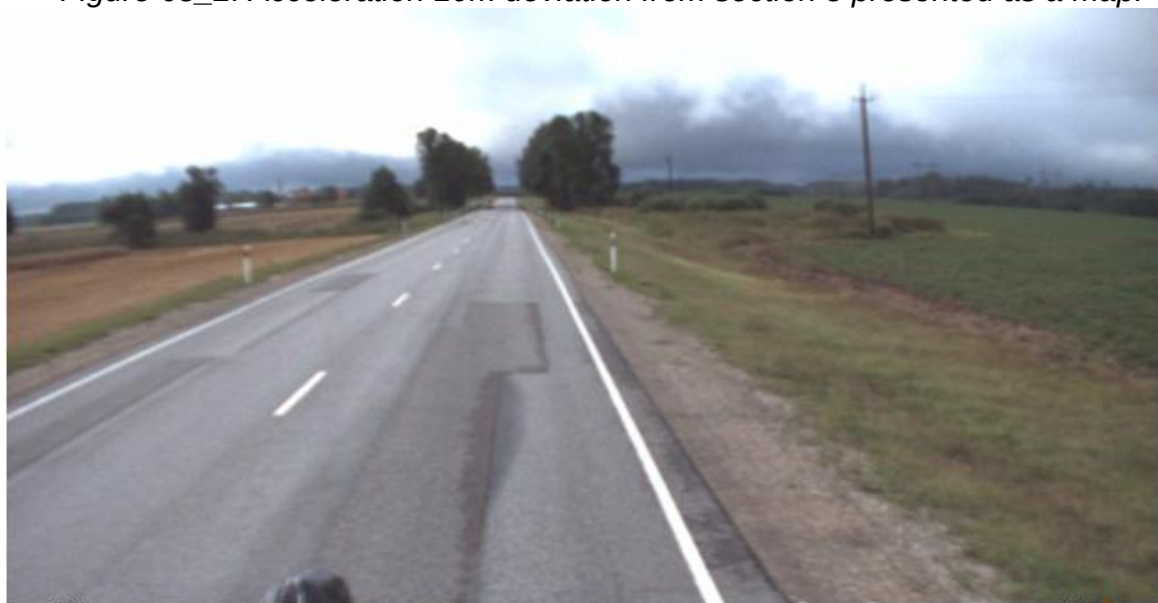
Figure 65\_3. The patches are seen on both lanes. The photo is from lane 1 at chainage 198 180m.

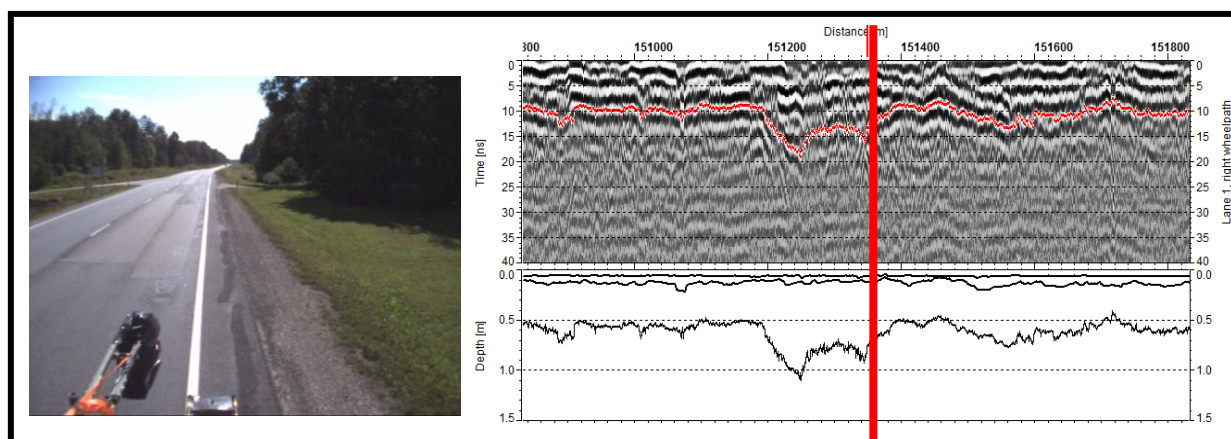
Figure 66\_3. The total structure thickness is quite varying. Red line on the GPR profile shows the example chainage where layer thickness changes from thick to thin. Still image is from the same chainage.

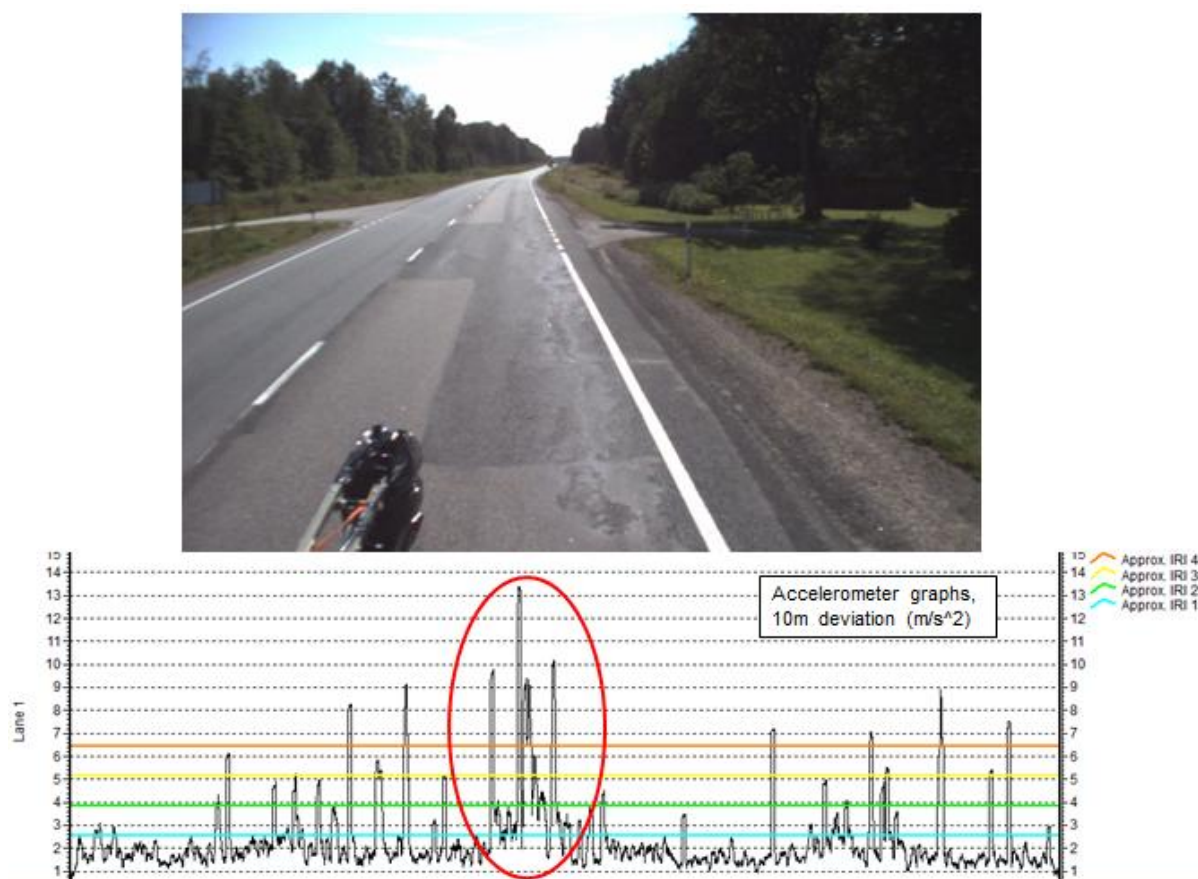
Figure 66\_8. Damages and patches that cause high roughness (151 400 m).

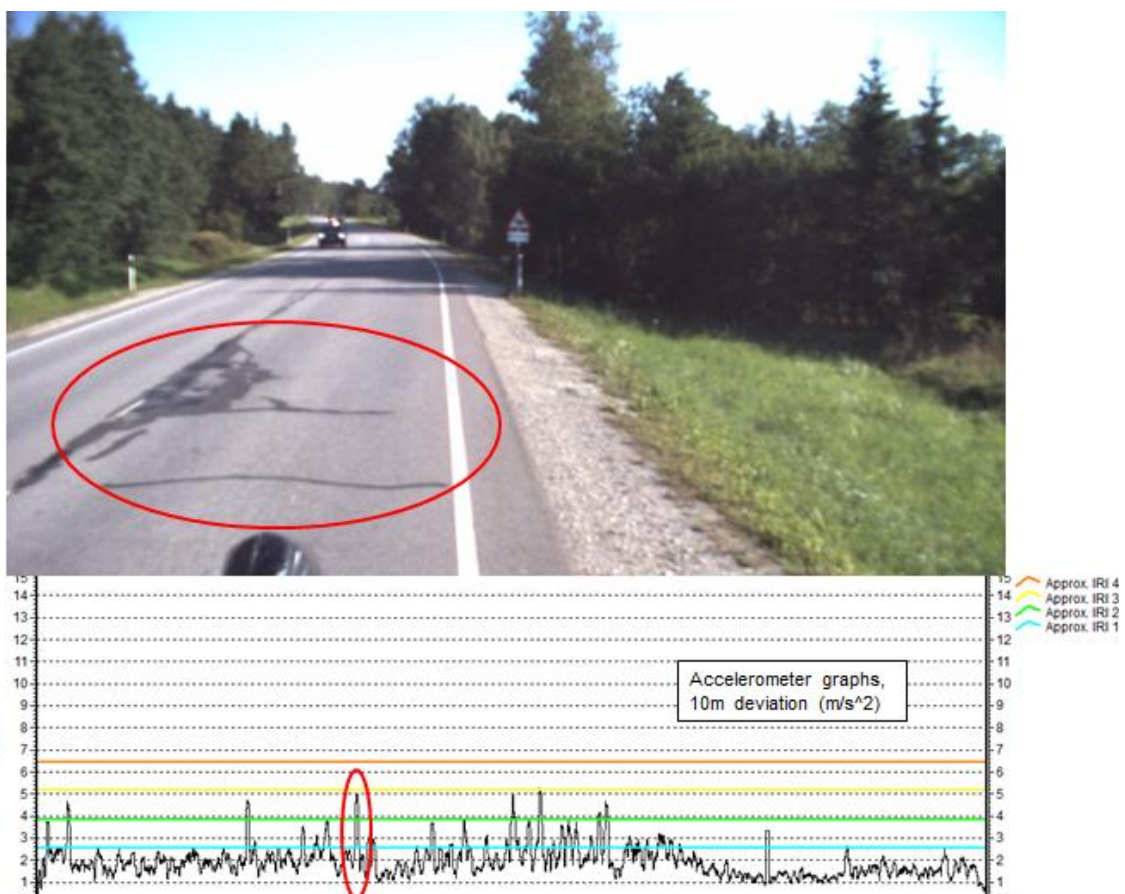
Figure 67\_4. Cracking in lane 1 at chainage 59 010m.

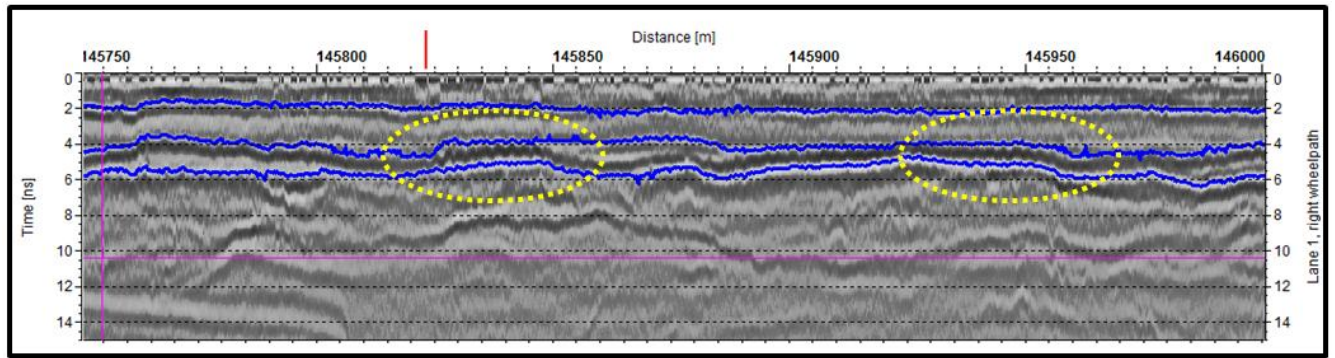
Figure 68\_1. Possible crack sections has been circled with yellow dashed lines.

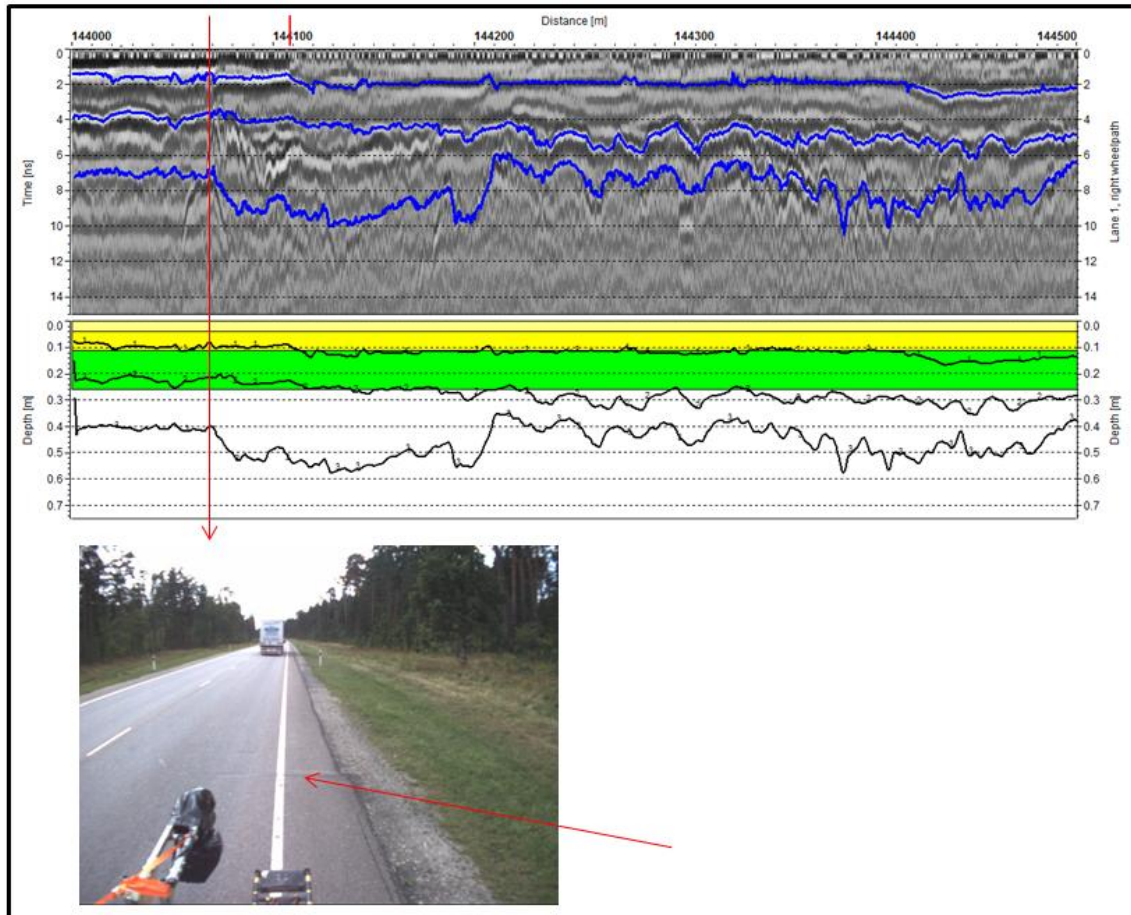
Figure 68\_2. Road structure changes at chainage 144060m. The point in the still image and transverse crack on the road surface have been marked with red arrows.

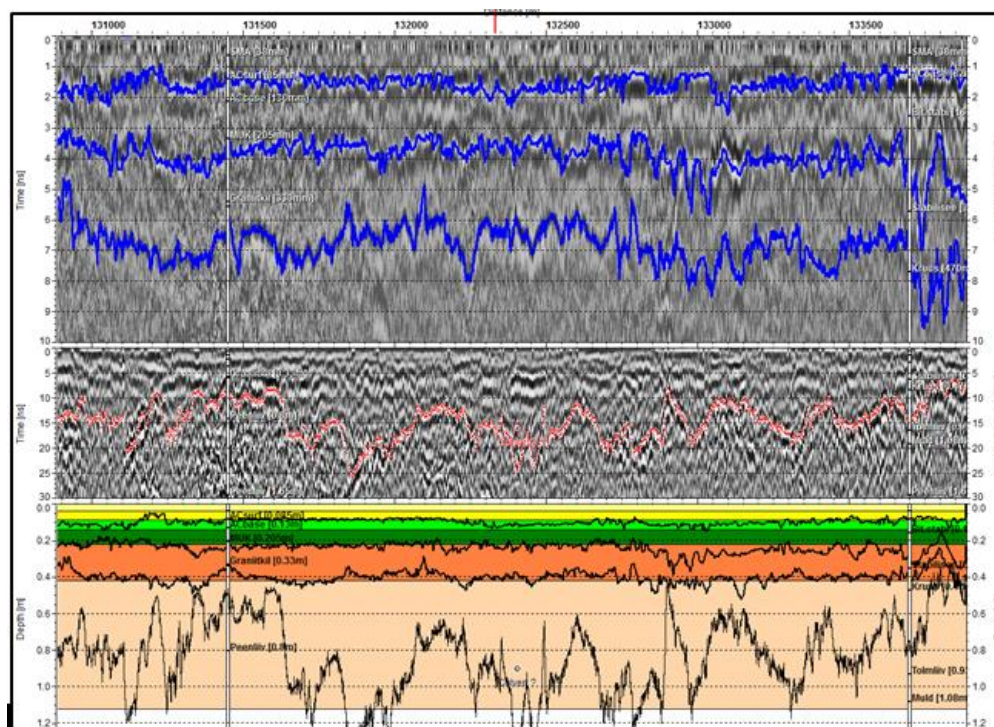
Figure 69\_3. Varying total thickness on section 9.

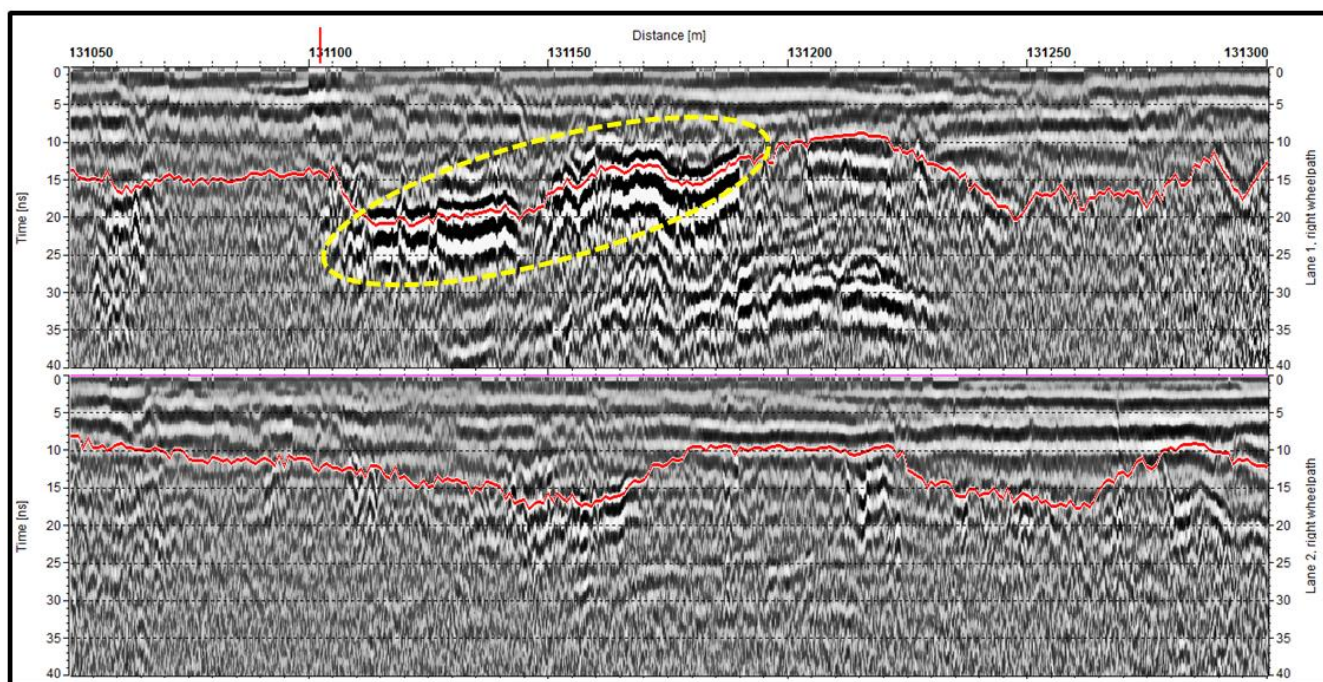
Figure 69\_4. Moisture susceptible materials in lane 1, circled with a yellow dashed lines.

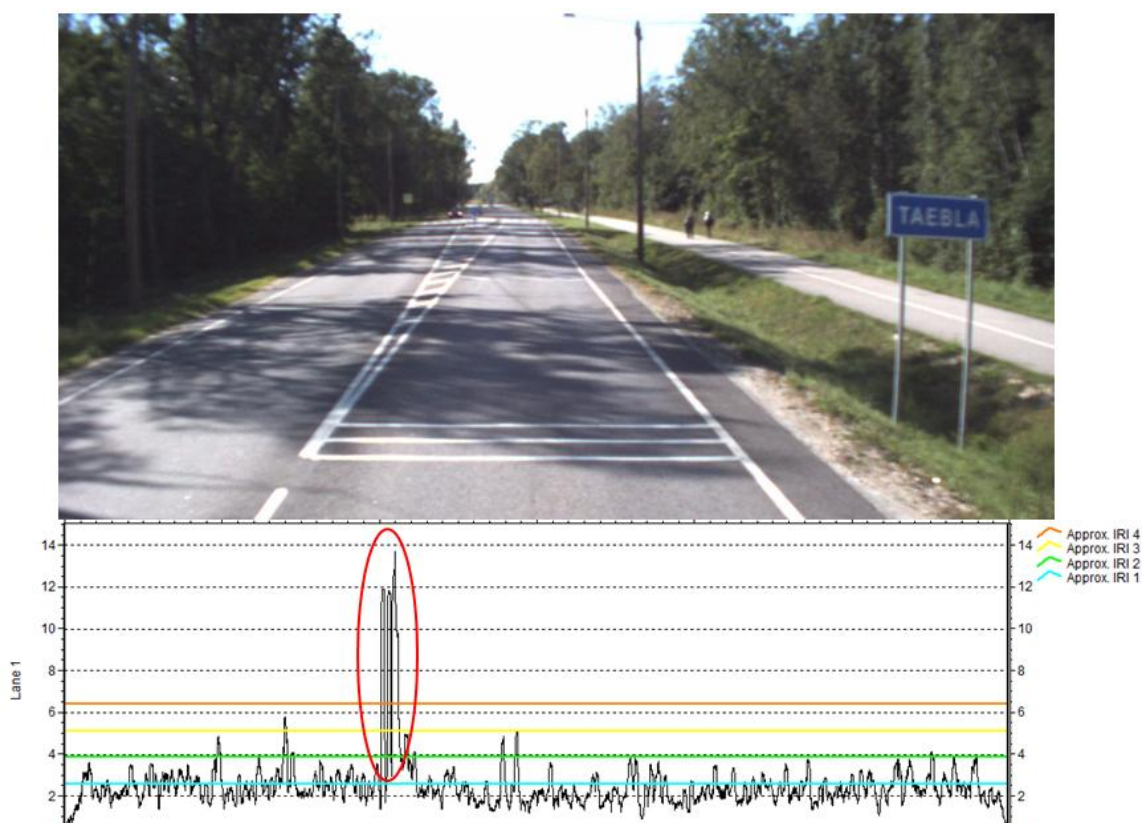
Figure 610\_4. Speed bumps in lane 1 at chainage 59000.
