# Eesti põhimaanteeede kvaliteedi hindamise ekspertuuring

Road construction quality surveys with  
non-destructive methods on selected sites in Estonia

Annele Matintupa, Tomi Herronen, Anssi Hiekkalahti and Timo Saarenketo

2012

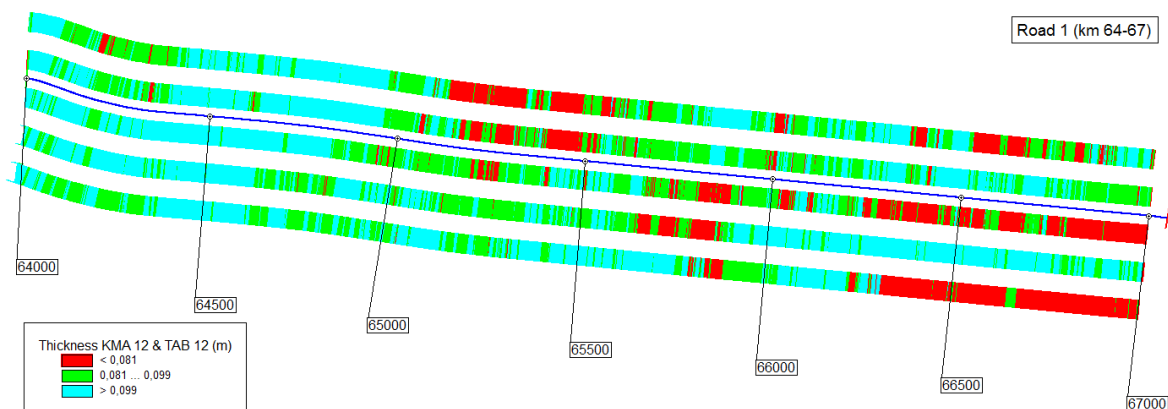
Mostly the layers fulfill the designed structure demands. Some deficiencies are detected, especially concerning the base course. Base course thickness is more than 10 % under planned, varying between 41-68 % of distance per survey line (see statistics in Appendix 1) and on average the undershoot is about 4-5 cm (in the more than 10 % under class). The fine sand embankment at the beginning of the section is also mostly thinner than it was planned to be. The layer thicknesses between different measured lines are at quite the same level, but some small variations can be seen. An example map presentation of layer thicknesses is shown in Figure 61\_1. All maps and statistics of interpreted layer thicknesses are presented in Appendix 1.

*Figure 61\_1: The interpreted layer thicknesses of KMA12 and TAB12. Thicknesses have been classified into three classes: red – thicknesses are more than 10% thinner than designed; green – thicknesses are  $\pm 10\%$  compared to designed structures and blue – thicknesses are more than 10% thicker than designed. The topmost line represents measured line in lane 2 on the left wheelpath, followed by other wheelpaths until the service lane (lowest line).*

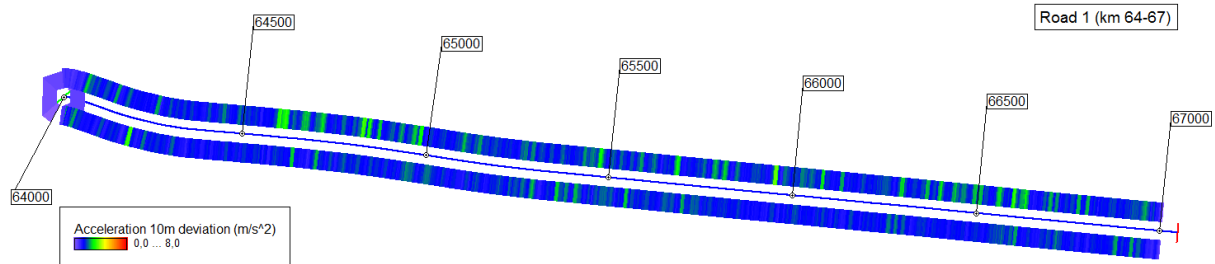
Road surface is in very good condition. It has been paved recently and there is no significant damage that could be seen in the accelerometer data (Figure 61\_4). There are no big acceleration spikes that can be seen in the 10m acceleration deviation data. There are some small spikes in the service lane acceleration data, but they are caused by gravel and dirt that is on the pavement (Figure 61\_5).

Figure 61\_4. Acceleration 10m deviation from section 1 presented as a map.

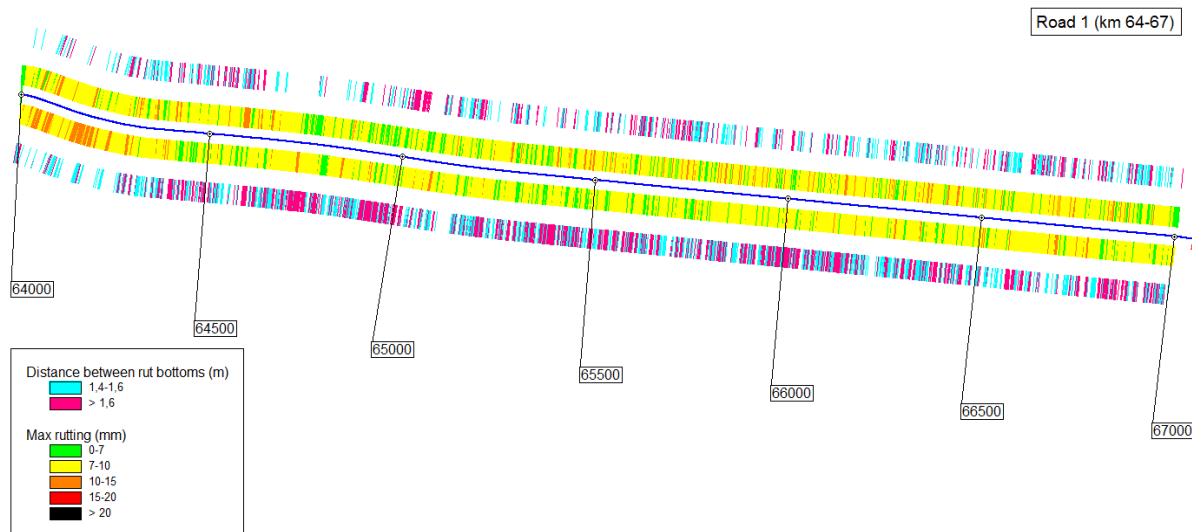
The road surface is in good condition. Rutting is low in whole section. Detailed results are presented statistically in Table 61\_2 and as a map in Figure 61\_6.

Figure 61\_6. Maximum rutting in both lanes (inner lines, colours from green to black) together with distance between rut bottoms (outer lines, colours pink and blue).

The results of this analysis could not explain fast rutting problems in section 1. One possibility is that the rutting is so called Mode 0 rutting, which means that asphalt is getting compacted due to high amount of air voids during the paving process. This however cannot be clearly shown afterwards.

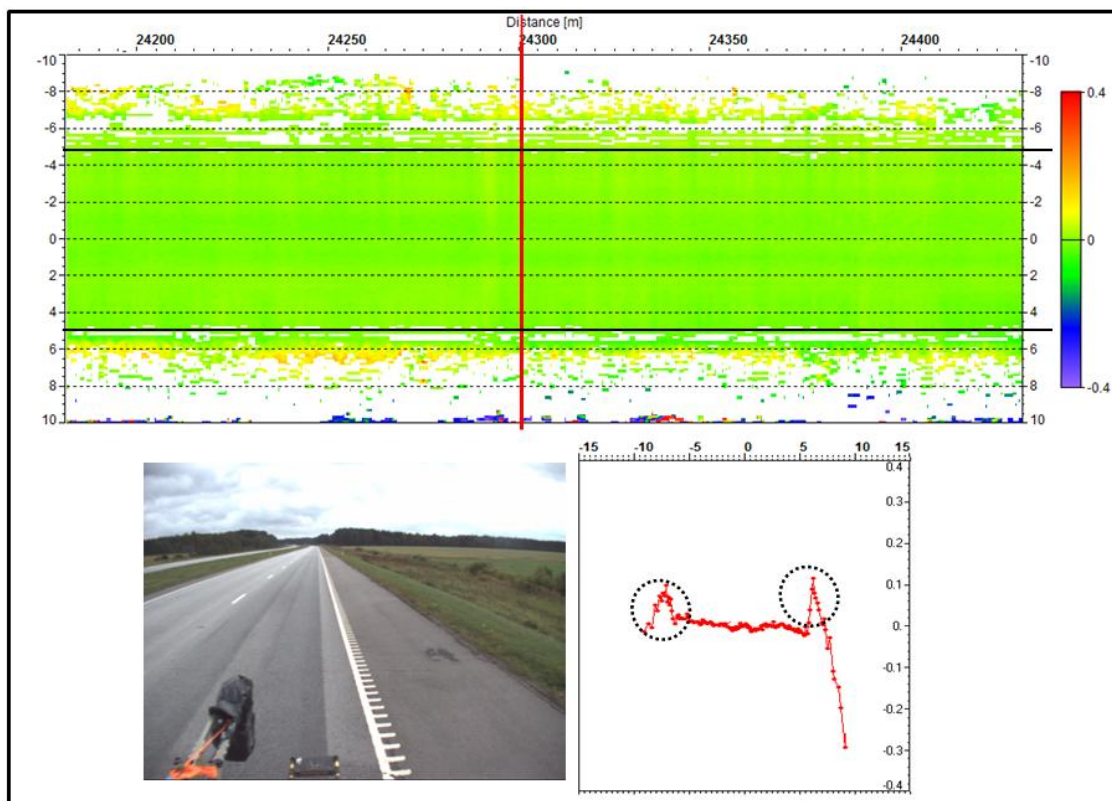
Laser scanner data showed that road surface is quite even, but small verges were on both sides in some places. The verges prevent the water from flowing away from the road surface (Figure 62\_1).

Figure 62\_1. Laser scanner surface elevation map from section 2 (road 1). The still image and cross section profile is picked from chainage 24 300m. The black lines on surface map represent the approximated road edges.

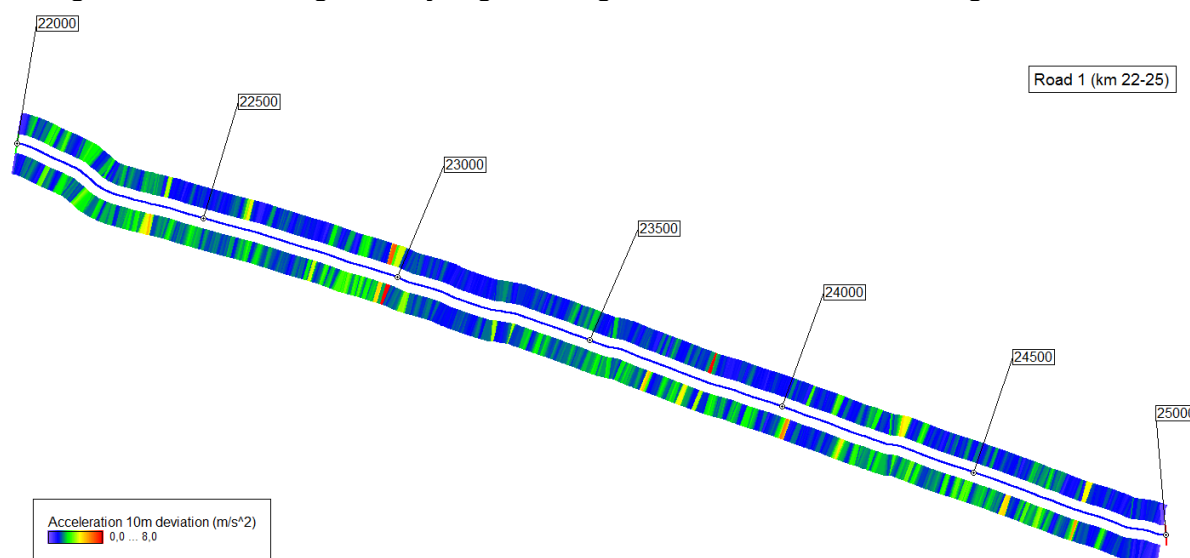
The road surface is generally in fairly good condition with small defects (Figure 62\_2). Lane 1 has rut repairs on the whole section, and has generally a bit higher roughness than lane 2. Service lane has not been paved at the same time as the two driving lanes, and has generally higher roughness than the two driving lanes.

Figure 62\_2: Acceleration 10m deviation from section 2 presented as a map.

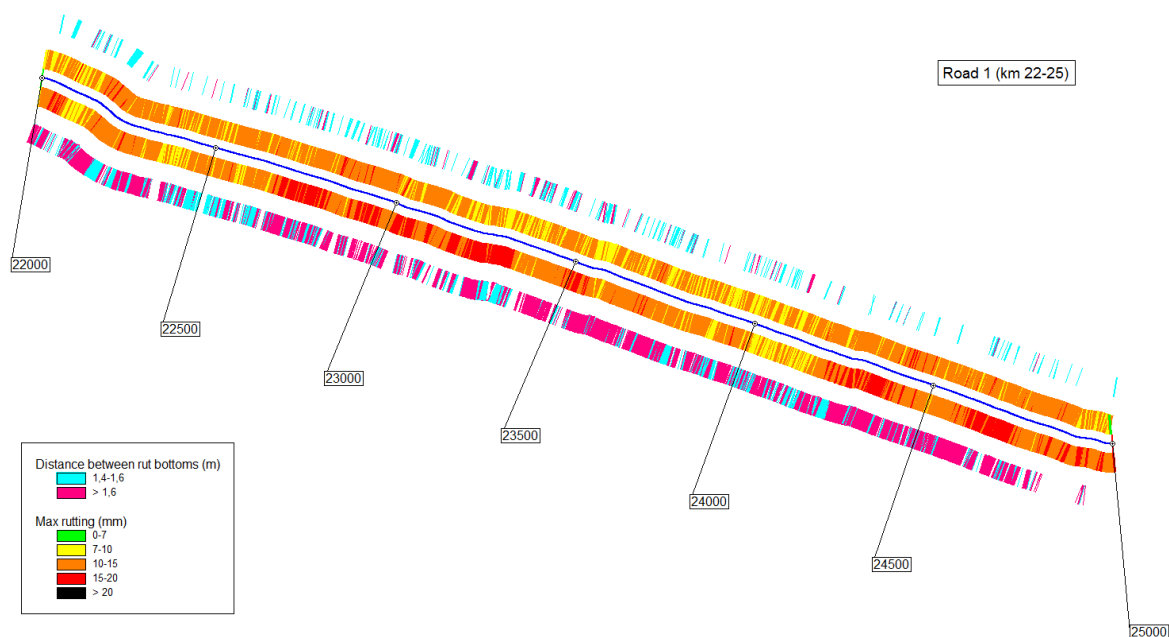
Rutting varies in this test section (Table 62\_2 and Figure 62\_4). Generally rutting is about 10 mm on most of the section, but there are places where rutting is almost 20 mm. In these places where rutting is high there are high verges at the side of the road, which could cause the higher rutting. Lane 1 has rut repairs on the whole section. Distance between rut bottoms indicates that rutting in lane 1 is caused mainly by heavy trucks and in lane 2 mainly because of studded tires (passenger cars).

Figure 62\_4. Maximum rutting in both lanes (inner lines, colours from green to black) together with distance between rut bottoms (outer lines, colours pink and blue).

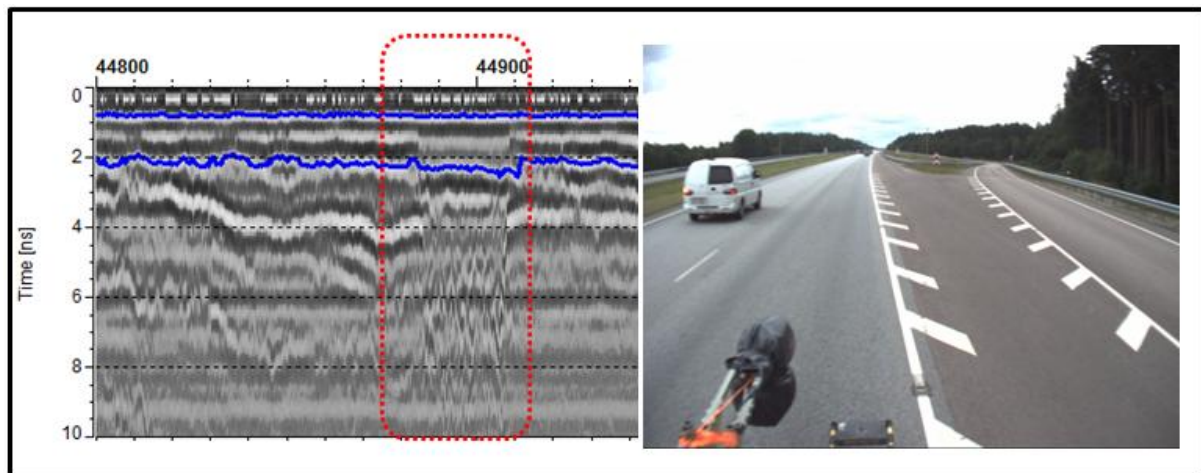
Around chainage 44 900 m a change in road structure was detected (Figure 63\_1). It could possibly be related to the ramp.

Figure 63\_1. GPR data and still image from chainage 44 8970m.

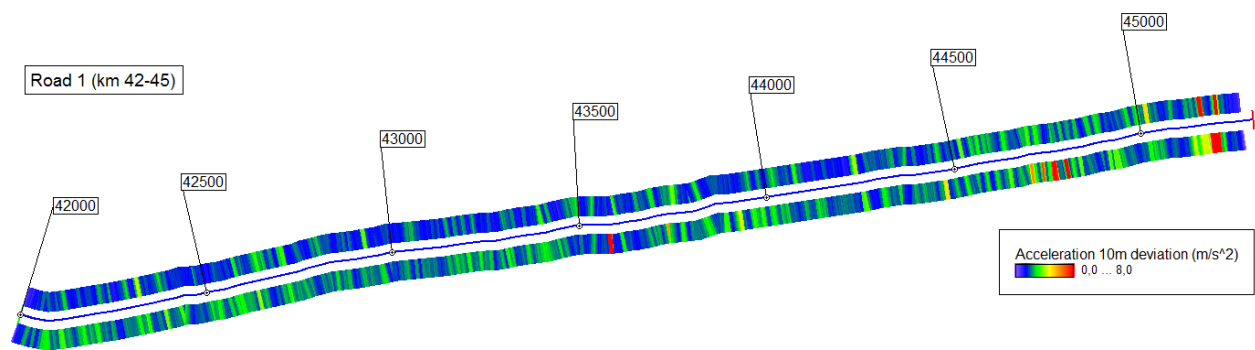
Generally the road surface is smooth with only small defects. Lane 1 has slightly higher general roughness than lane 2, but the difference is not great (Figure 63\_2). Service lane has not been paved at the same time as the two driving lanes, and generally has higher roughness than the two driving lanes. The bridge at the end of the section is in very poor condition.

Figure 63\_2: Acceleration 10m deviation from section 3 presented as a map.

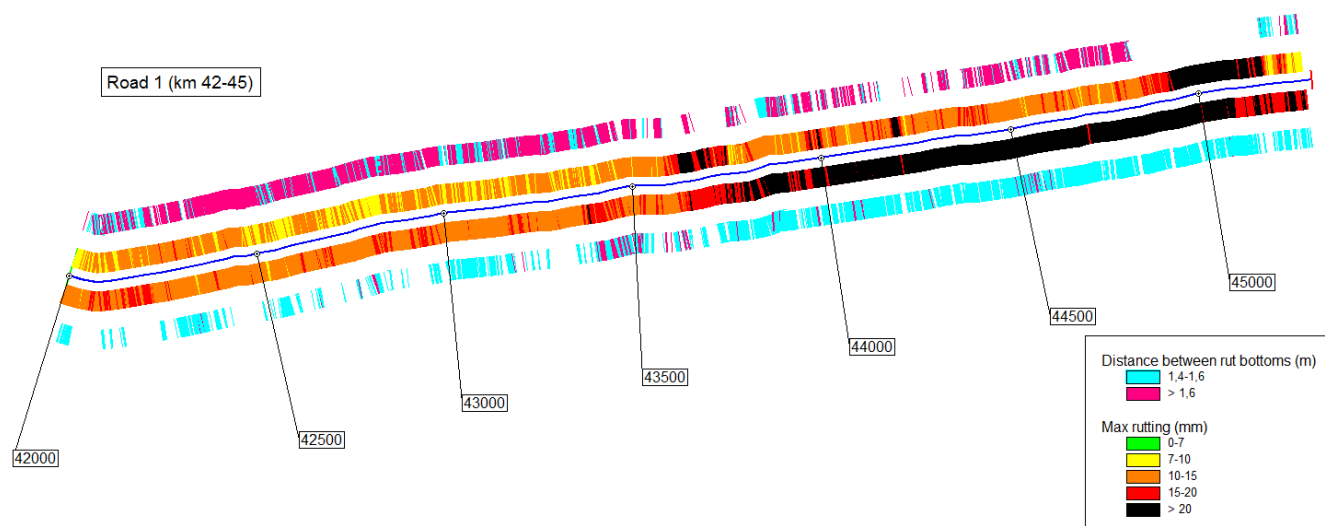
Rutting is high in this section. It is especially high in lane 1 with the highest rutting found at the end of the section, from 43 600 m to 45 300 m. Distance between rut bottoms indicates that rutting on lane 1 is caused mainly because of studded tires (passenger cars). In lane 2 distances between rut bottoms is higher on most of the section as seen in the Figure 63\_5, which indicates that it could be caused by heavy trucks.

Figure 63\_5. Maximum rutting in both lanes (inner lines, colours from green to black) together with distance between rut bottoms (outer lines, colours pink and blue).

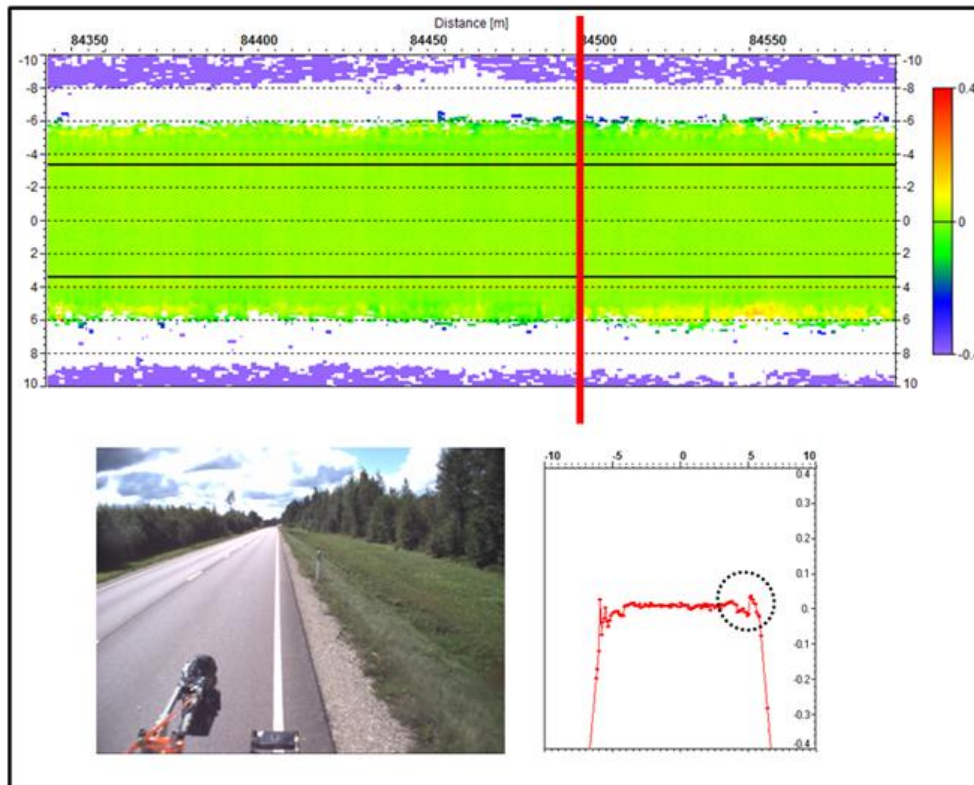
In general road shape is in good condition, minor verges were detected locally (Figure 64\_3). Laser scanner rainbow map showed that road section has good crown section; two sided cross fall (Figure 64\_4).

Figure 64\_3. Laser scanner surface elevation map from section 4 (road 3). The still image and cross section profile is picked from chainage 84 495m. The black lines on surface map represent the approximated road edges.

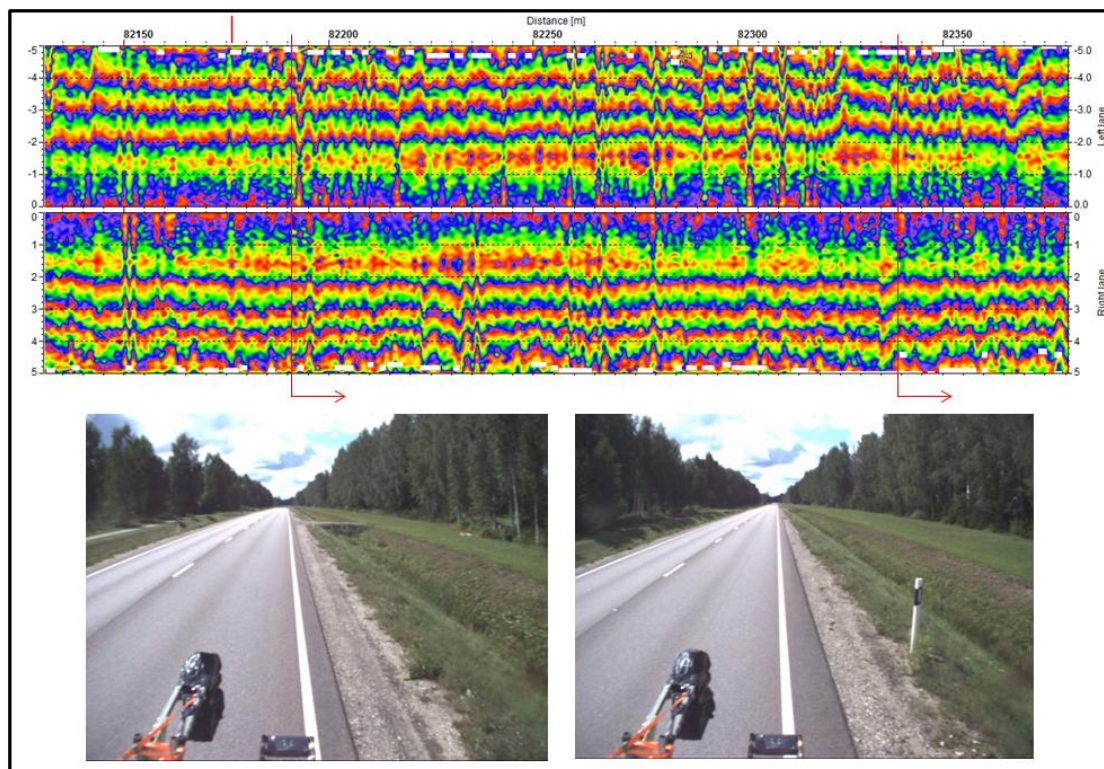
Figure 64\_4. Laser scanner rainbow map from section 4 (road 3) from 82 130m to 82 380m. Each complete colour palette represents 30mm change in surface level relative to the centerline.

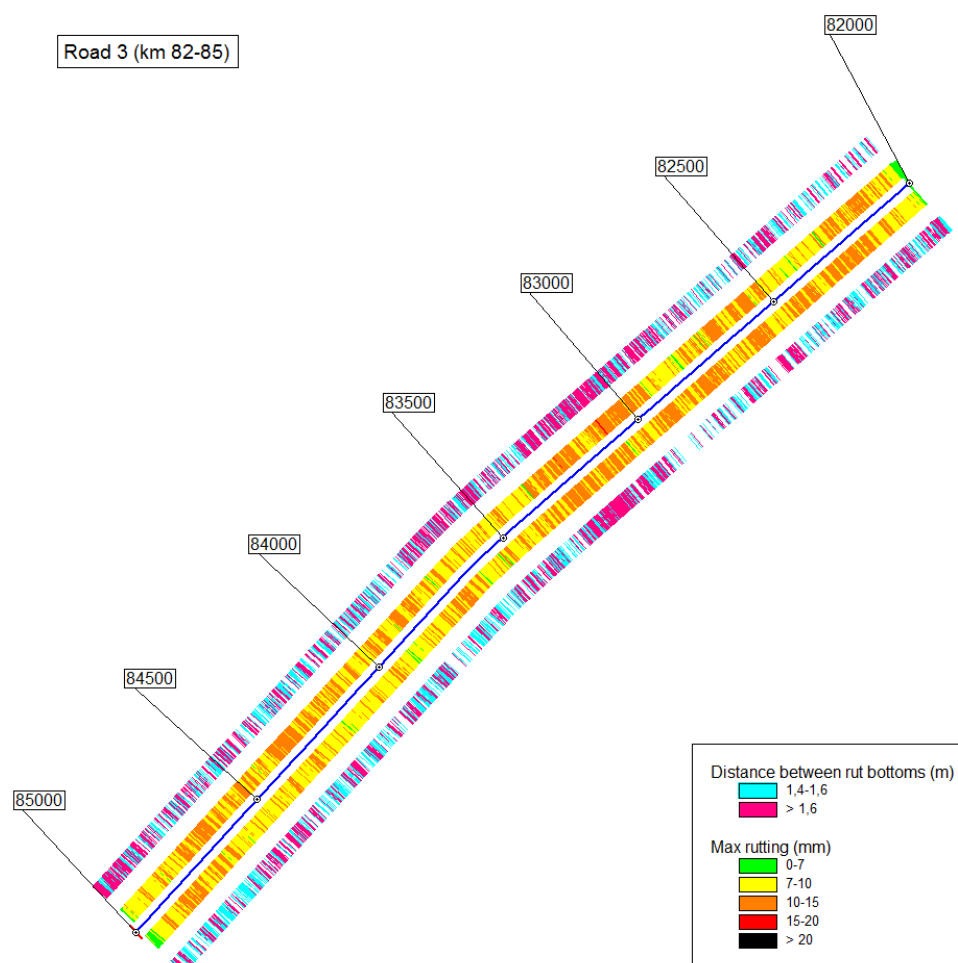
Rutting is generally low in the section. Average rutting for both lanes is less than 10 mm (Table 64\_2). In places rutting is between 10 and 15 mm (Figure 64\_7).

Figure 64\_7. Maximum rutting in both lanes (inner lines, colours from green to black) together with distance between rut bottoms (outer lines, colours pink and blue).

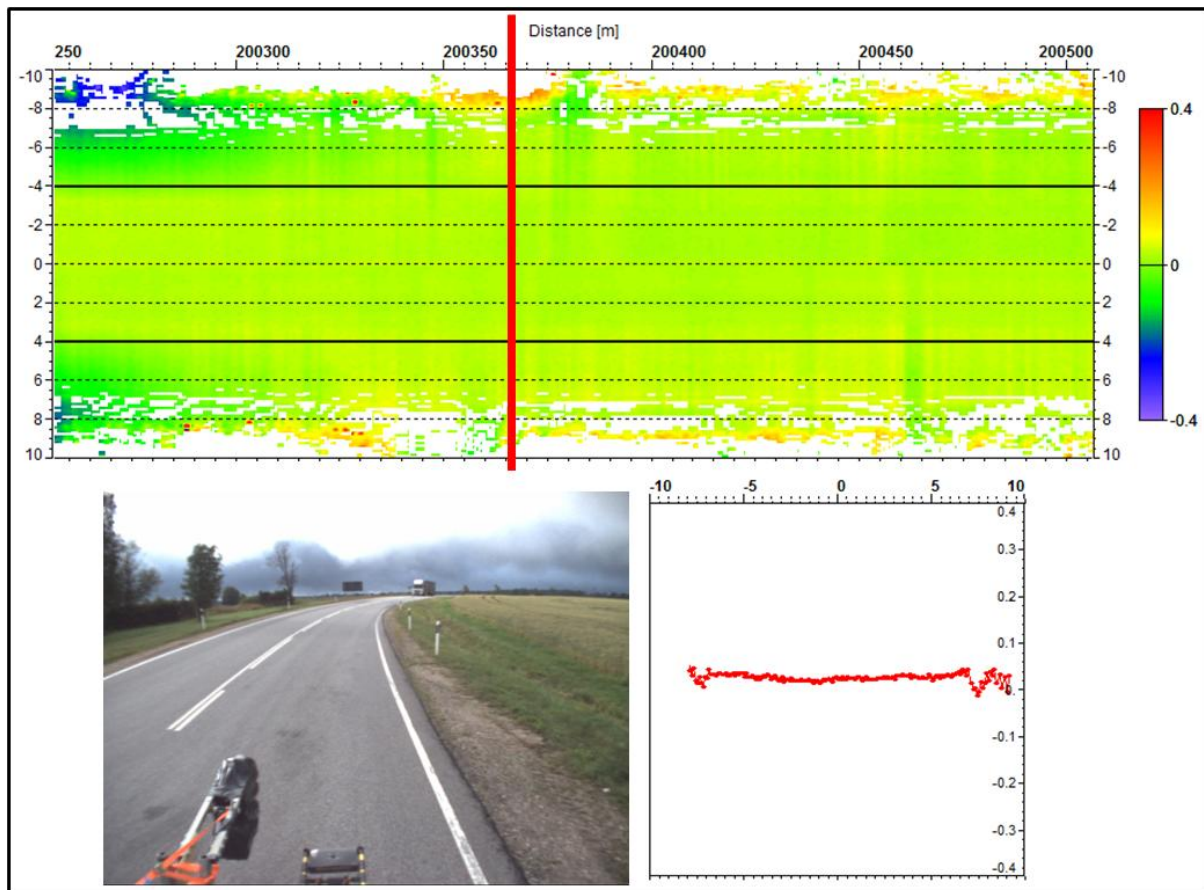
From laser scanner data it was observed that in places road is located in a really flat area, in the middle of a field area (Figure 65\_1). Road cross fall is excellent crown section.

Figure 65\_1. Laser scanner surface elevation map from section 5 (road 3). The still image and cross section profile is picked from chainage 200 360m. The black lines on the surface map represent the approximated road edges.

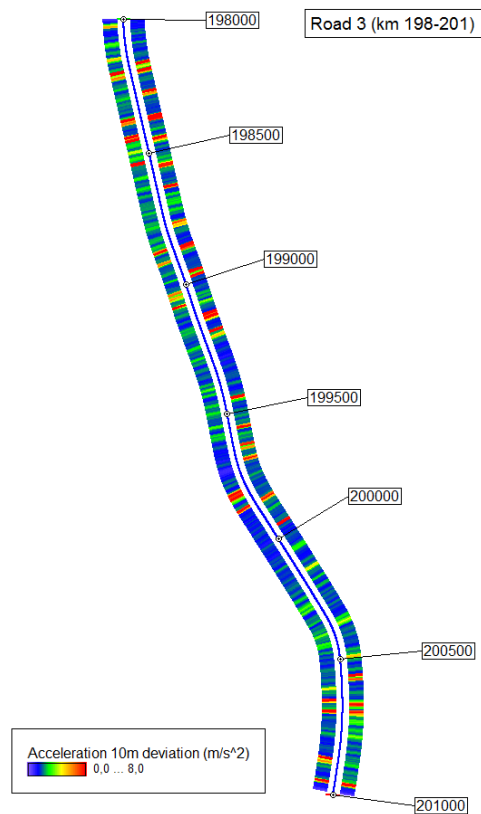
The pavement in this road section is not in good condition and has a lot of patches (Figure 65\_3). These patches cause high acceleration values that can be seen with red color on the map presentation (Figure 65\_2). All of the bigger spikes in the acceleration graphs are caused by the patches.

Figure 65\_2: Acceleration 10m deviation from section 5 presented as a map.

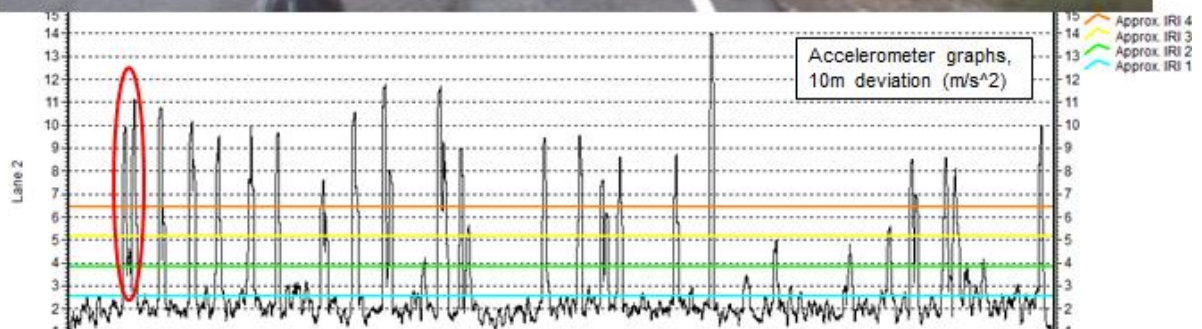
Figure 65\_3. The patches are seen on both lanes. The photo is from lane 1 at chainage 198 180m.

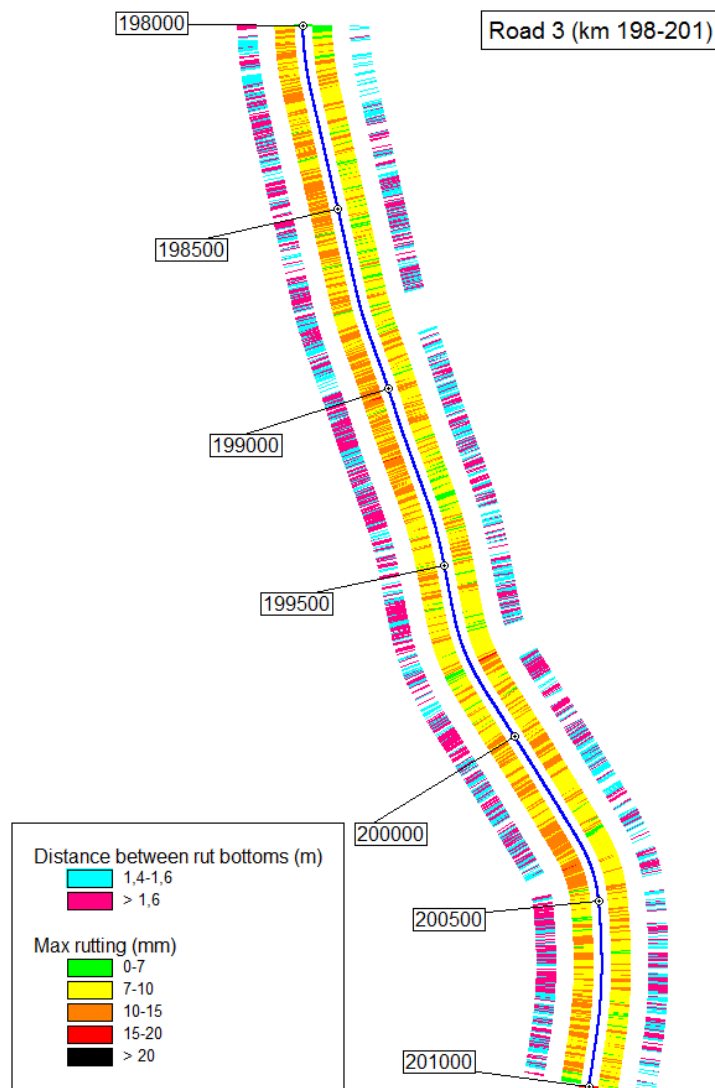
*Figure 65\_4. Maximum rutting in both lanes (inner lines, colours from green to black) together with distance between rut bottoms (outer lines, colours pink and blue).*

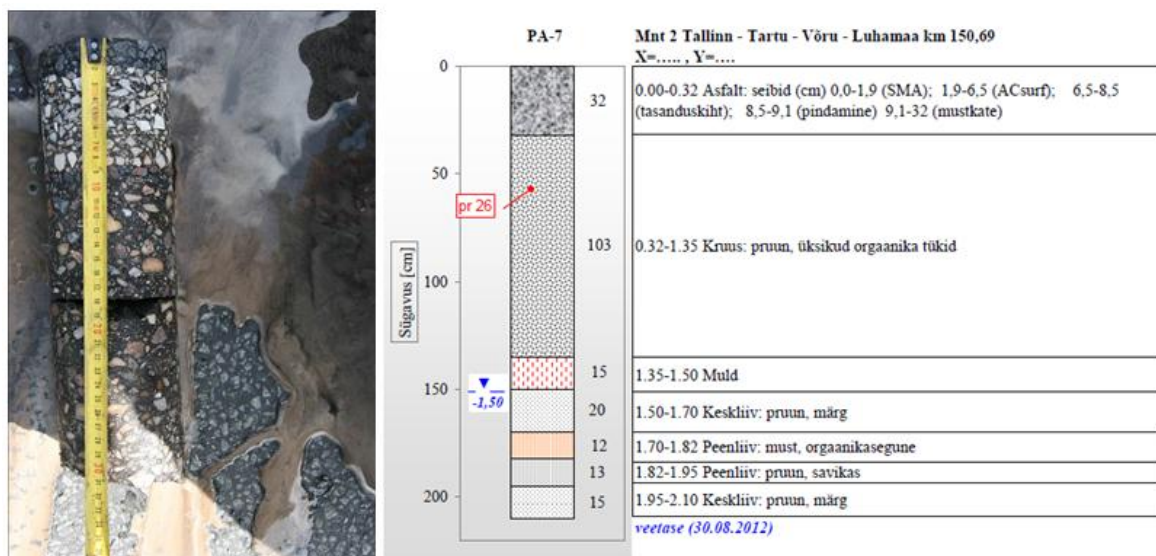
surface is probably not MUK 16/32, because this layer was not found in drill core (Figure 66\_1). This layer surface is maybe the leveling course and it seems to be continuous throughout the section. Pavement thickness is more than 10 % thinner through almost the entire section. Average undershoot is between 1,7-2,0 cm. Maps and statistics of interpreted layer thicknesses are shown in Appendix 6.

According to drill core data (Figure 66\_1) it is doubtful that the road actually has the precoated chippings MUK 16/32. Instead the road structure has 2cm “tasanduskiht” and below that 0,6cm “pindamiskiht” (Figure 66\_2). The total thickness of road structure is variable, example in Figure 66\_3.

Figure 66\_1. The photo (left) and layer thicknesses of drill core.

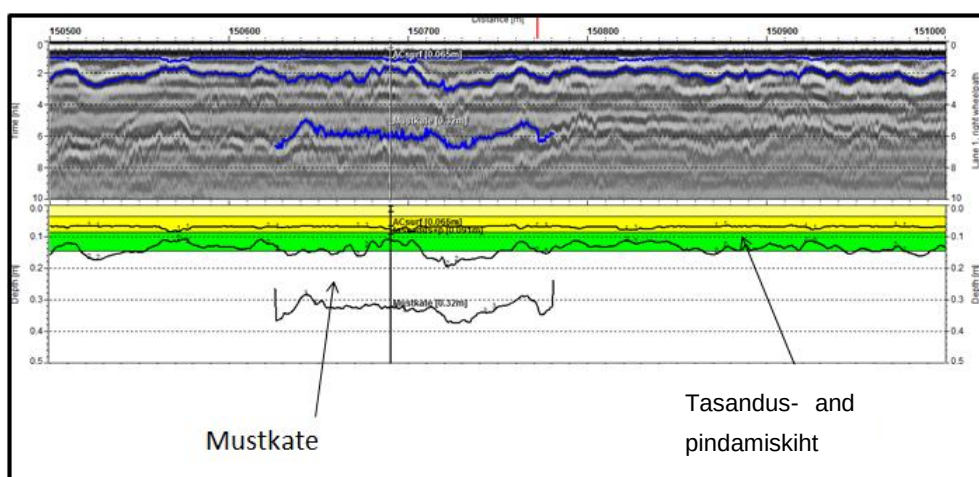
Figure 66\_2. Yellow areas presents the KMA and PAB layers, green area should be stabilisation layers, but it seems that below the pavement is “tasandus- and pindamiskiht”. As an example short sections of lower surface of mustkate has been interpreted in the middle of figure.

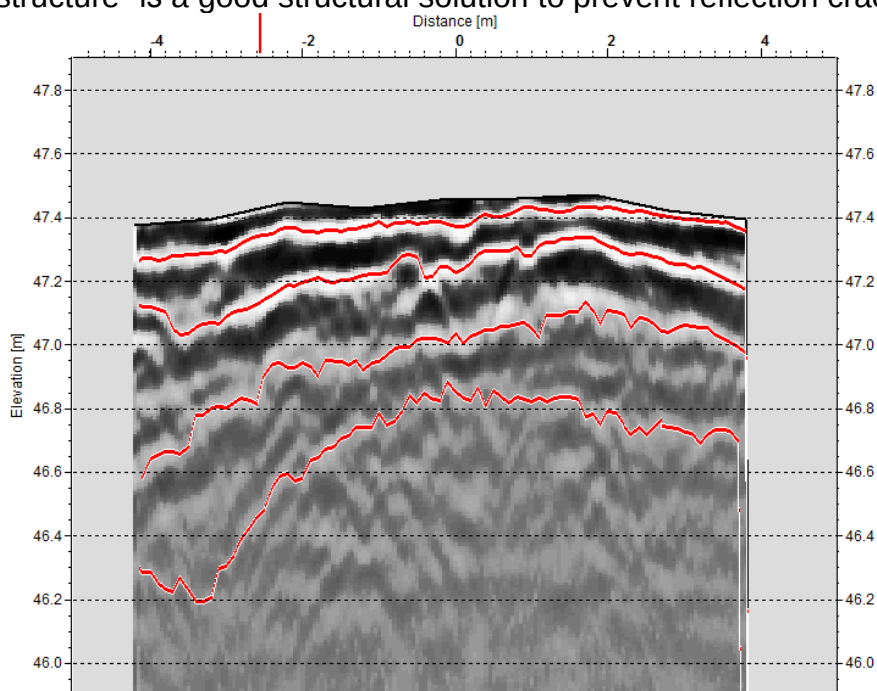
According to GPR cross section profile from chainage km 152, road has been widened on the left side (Figure 66\_4). Widened structures seem to be like steps. This “Step structure” is a good structural solution to prevent reflection cracking.

Figure 66\_4. GPR cross section from chainage km 152.

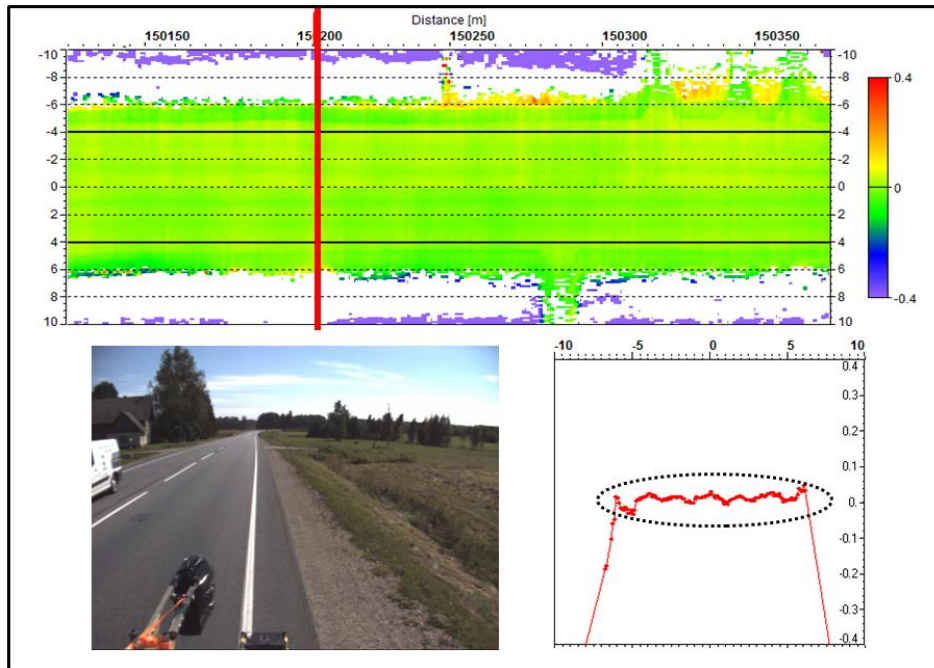
Laser scanner data shows that road has quite deep ruts. Ruts are seen both in the surface elevation map and in cross sections (Figure 66\_5). From the rainbow maps it can be seen that the changes in road surface are in the same locations as access roads (Figure 66\_6). In earlier studies, in the context of the ROADEX projects for example, it was noticed that the culverts of access roads are one of the most critical

Figure 66\_5. Laser scanner surface elevation map from section 6 (road 2). The still image and cross section profile is picked from chainage 150 250m. The black lines on surface map represent the approximated road edges. A black dashed line is used to indicate the location of ruts observed on the road surface.

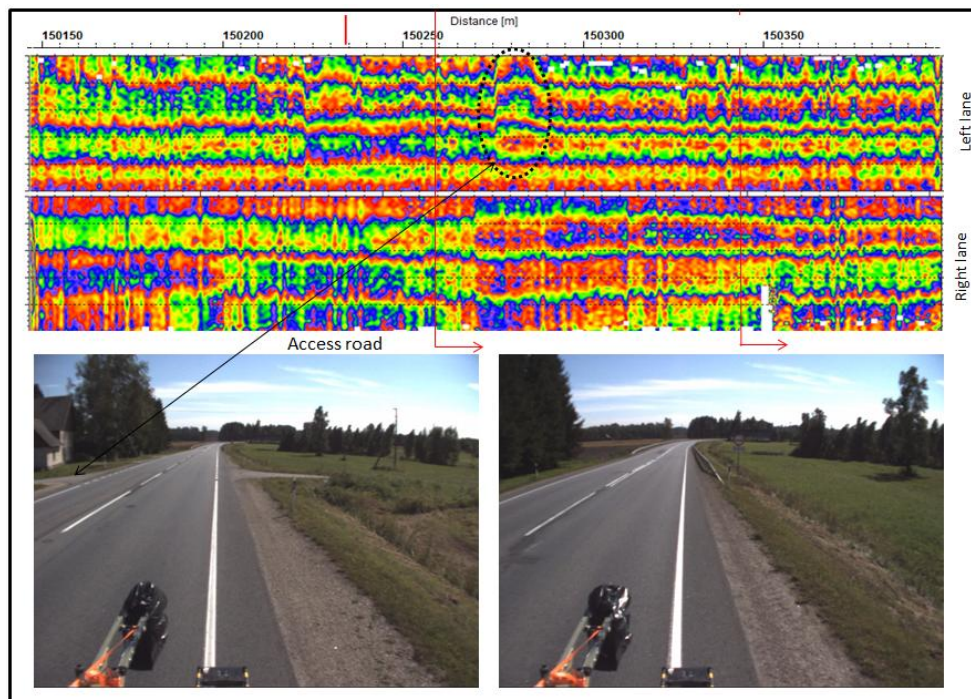
parts of a road drainage system. The culverts often have problems; they can be totally missing, clogged or installed faultily. The inadequate culverts cause further problems like deformations in the road surface and frost heave problems.

Figure 66\_6. Laser scanner rainbow map from section 6 (road 2) from 150 150m to 150 400m. Each complete color palette represents 30mm change in surface level relative to the centerline. The access road and the deviation it has caused in the road surface has been marked in the figure.

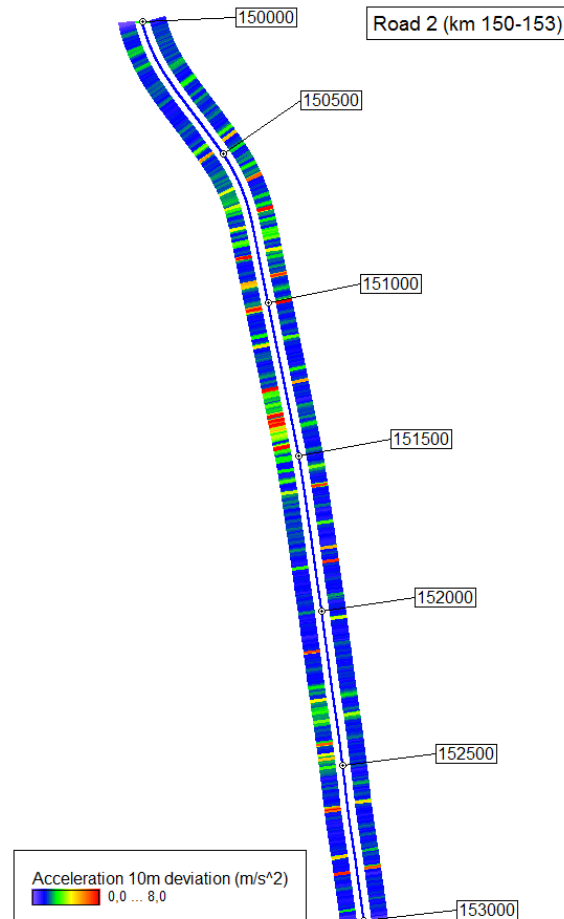
The pavement in this road section is not in good condition and has a lot of patches and transverse cracks that have been patched. These patches and transverse cracks are the cause of the high roughness in the section. Lane 1 has higher roughness and more patches than lane 2 (Figure 66\_7).

Figure 66\_7. Acceleration 10m deviation from section 6 presented as a map.

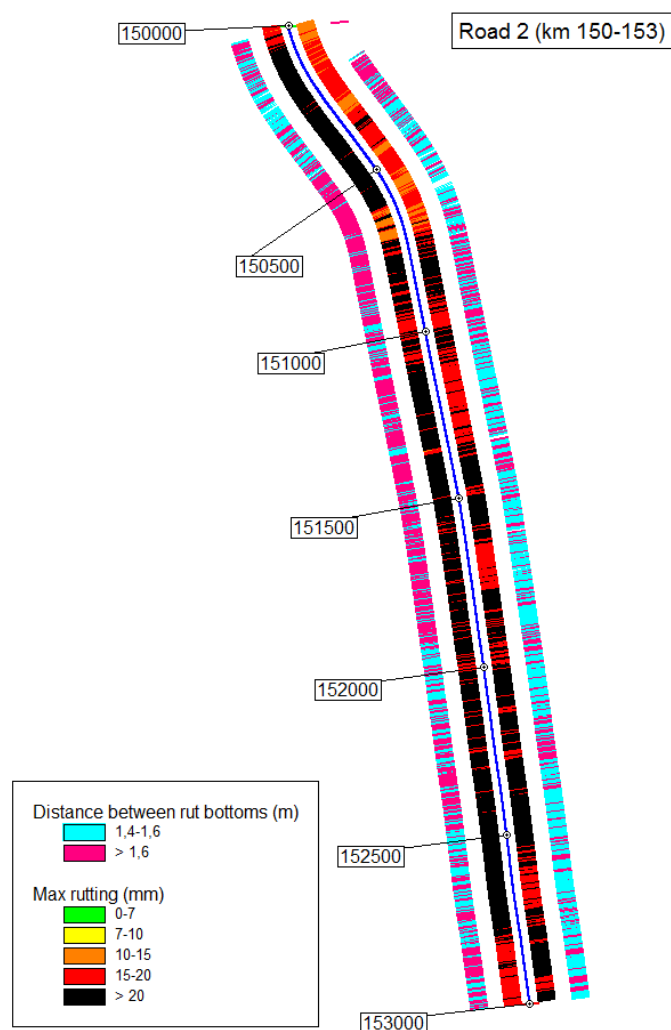
Rutting is high in the road section. Maximum rutting is over 20 mm in almost the entire section in the lane 1 (Table 66\_2). Lane 2 also has high rutting, but slightly lower than lane 1. Distance between rut bottoms indicates that rutting in lane 1 is caused mostly by heavy trucks and in lane 2 by studded tires (passenger cars), Figure 66\_9.

Figure 66\_9: Maximum rutting in both lanes (inner lines, colours from green to black) together with distance between rut bottoms (outer lines, colours pink and blue).

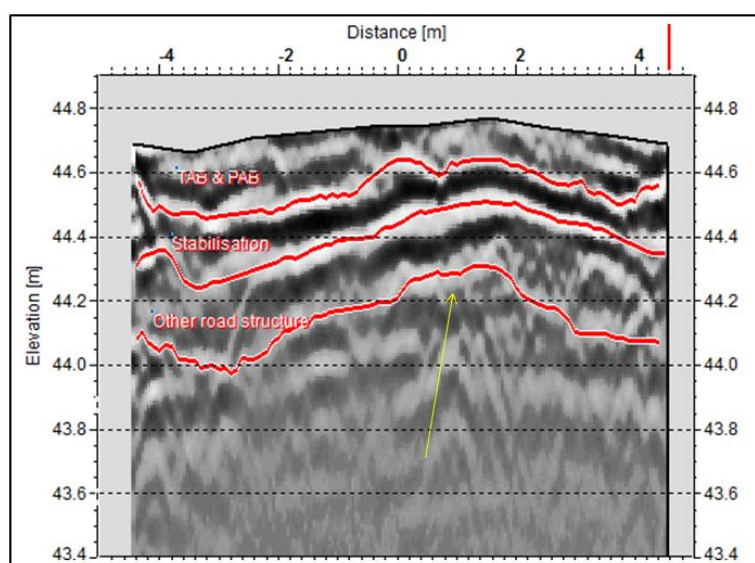
Figure 67\_1 presents the GPR cross section data from chainage 60, which shows that the total structure thickness is at the thinnest in the middle of road.

Figure 67\_1. The GPR cross-section from chainage 60km. Yellow arrow shows the location of the thinnest structures.

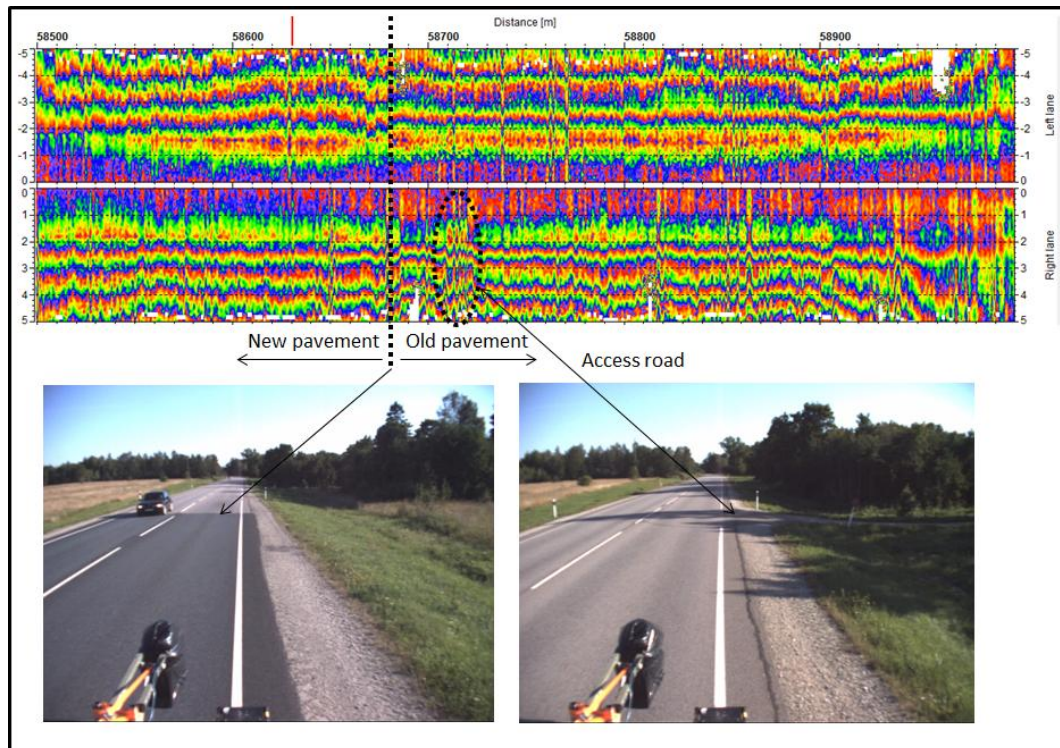
Laser scanner data detected the deformations in the road surface and its slopes. Road surface has ruts and inner slopes have bulged in places (Appendix 7). As in the previous section, the problems possibly caused by access roads are also seen in the rainbow map (Figure 67\_2).

Figure 67\_2. Laser scanner rainbow map from section 7 (road 4) from 58 500 to 59 000 m. Each complete color palette represents 30mm change in surface level relative to the centerline. The access road and the deviation it has caused in the road surface have been marked in the figure. The beginning of this section has been repaved recently and it is clearly seen that the new pavement is more even than the old pavement.

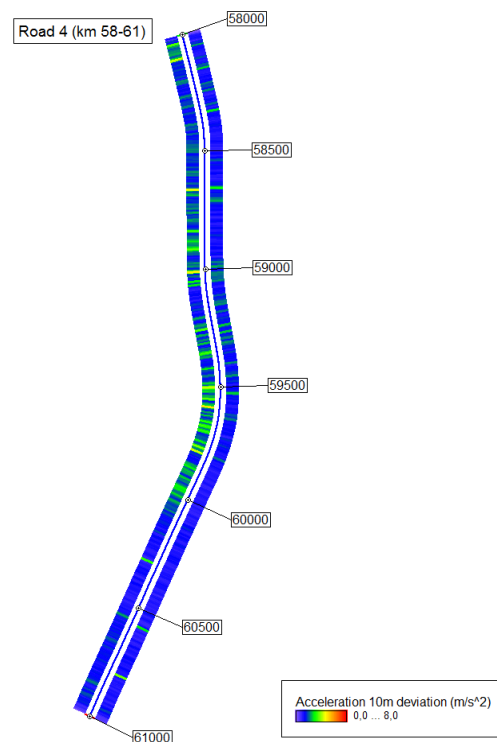
The pavement is in fairly good condition with some small defects. Generally lane 1 has slightly higher roughness than lane 2, but both lanes have low general roughness (Figure 67\_3). The older pavement between 58660 m and 59790 m has higher roughness than the other road section and some damage (Figure 67\_4).

Figure 67\_3. Acceleration 10m deviation from section 7 presented as a map.

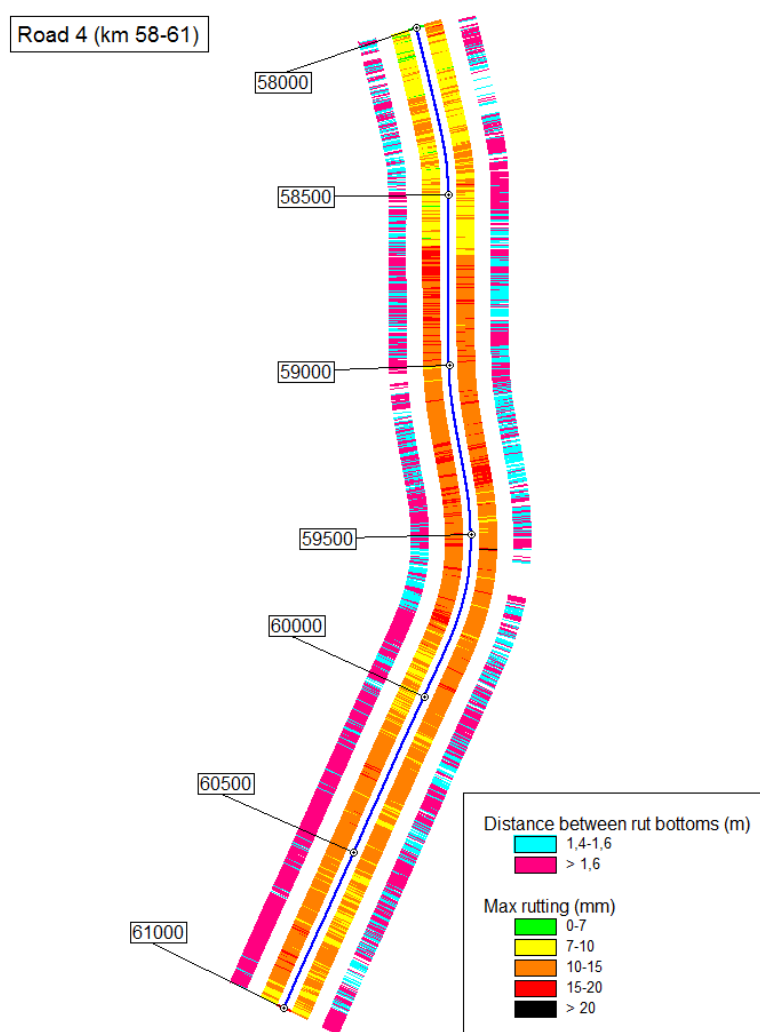
Rutting varies in the road section. The new pavement at the beginning of the section until about 58660 m has low rutting. The old pavement between 58660 m and 59790 m has 10-20 mm rutting. After 59790 m rutting is mostly between 10-15 mm. Especially at the end of the road section (after 59790 m) and in lane 1 the distance between rut bottoms indicates that rutting was caused by heavy trucks. In that part of the road section and especially in lane 1, the pavement thickness was found to be the thinnest. Rutting statistics from this road section are shown in Table 67\_2 and rutting is presented on the map in Figure 67\_5.

Figure 67\_5. Maximum rutting in both lanes (inner lines, colours from green to black) together with distance between rut bottoms (outer lines, colours pink and blue).

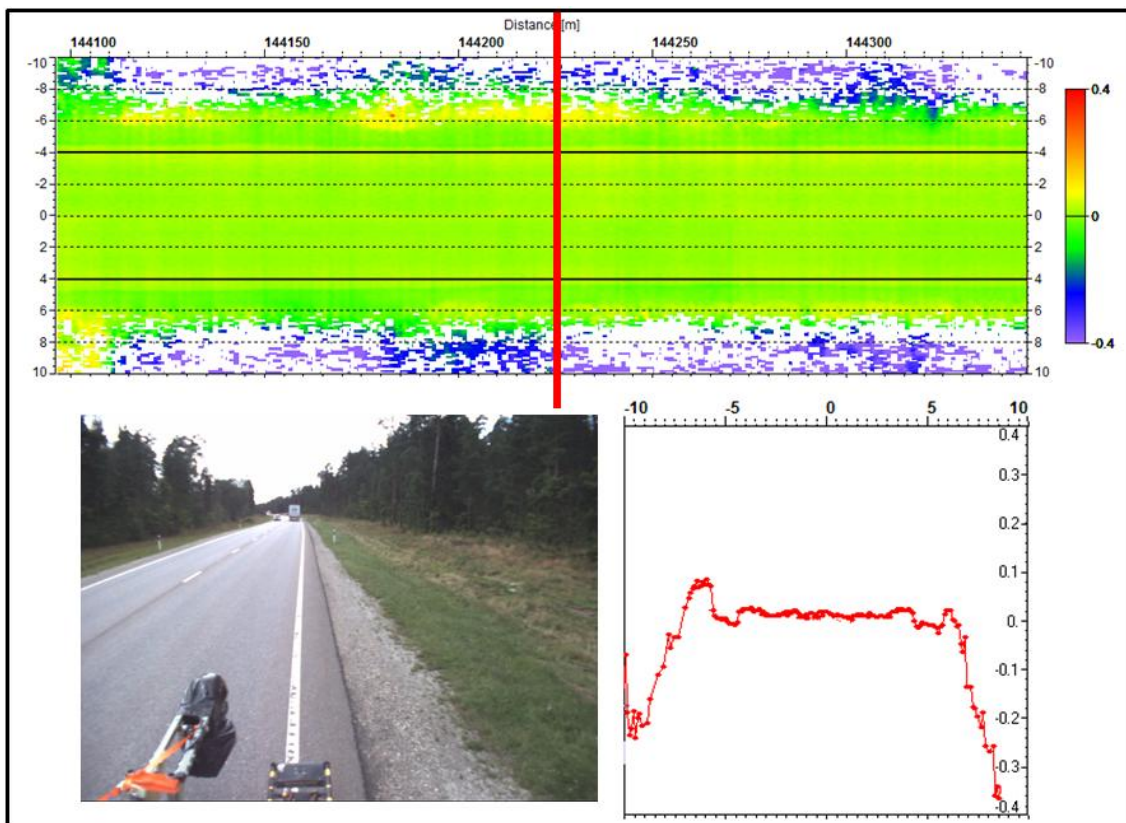
Laser scanner data showed slight deformation on road surface and inner slopes (Figure 68\_3).

Figure 68\_3. Laser scanner surface elevation map from section 8 (road 4). The still image and cross section profile is picked from chainage 144 225m. The black lines on surface map represent the approximated road edges.

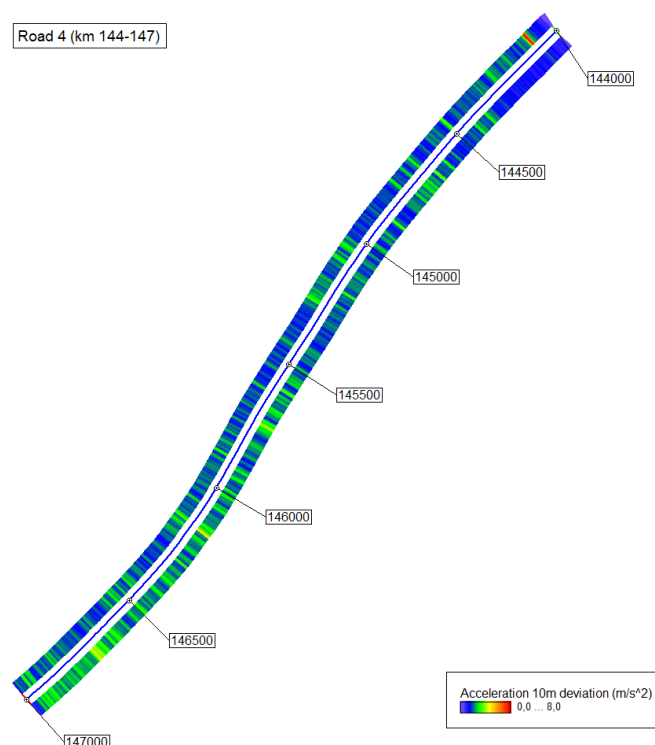
Road is even and the longitudinal roughness on both lanes is quite low (Figure 68\_4). There are a couple of acceleration peaks that are caused by transverse cracks, but generally the section doesn't have lot of pavement damage.

Figure 68\_4. Acceleration 10m deviation from section 8 presented as a map.
