# Eesti põhimaanteeede kvaliteedi hindamise ekspertuuring

Road construction quality surveys with  
non-destructive methods on selected sites in Estonia

Annele Matintupa, Tomi Herronen, Anssi Hiekkalahti and Timo Saarenketo

2012

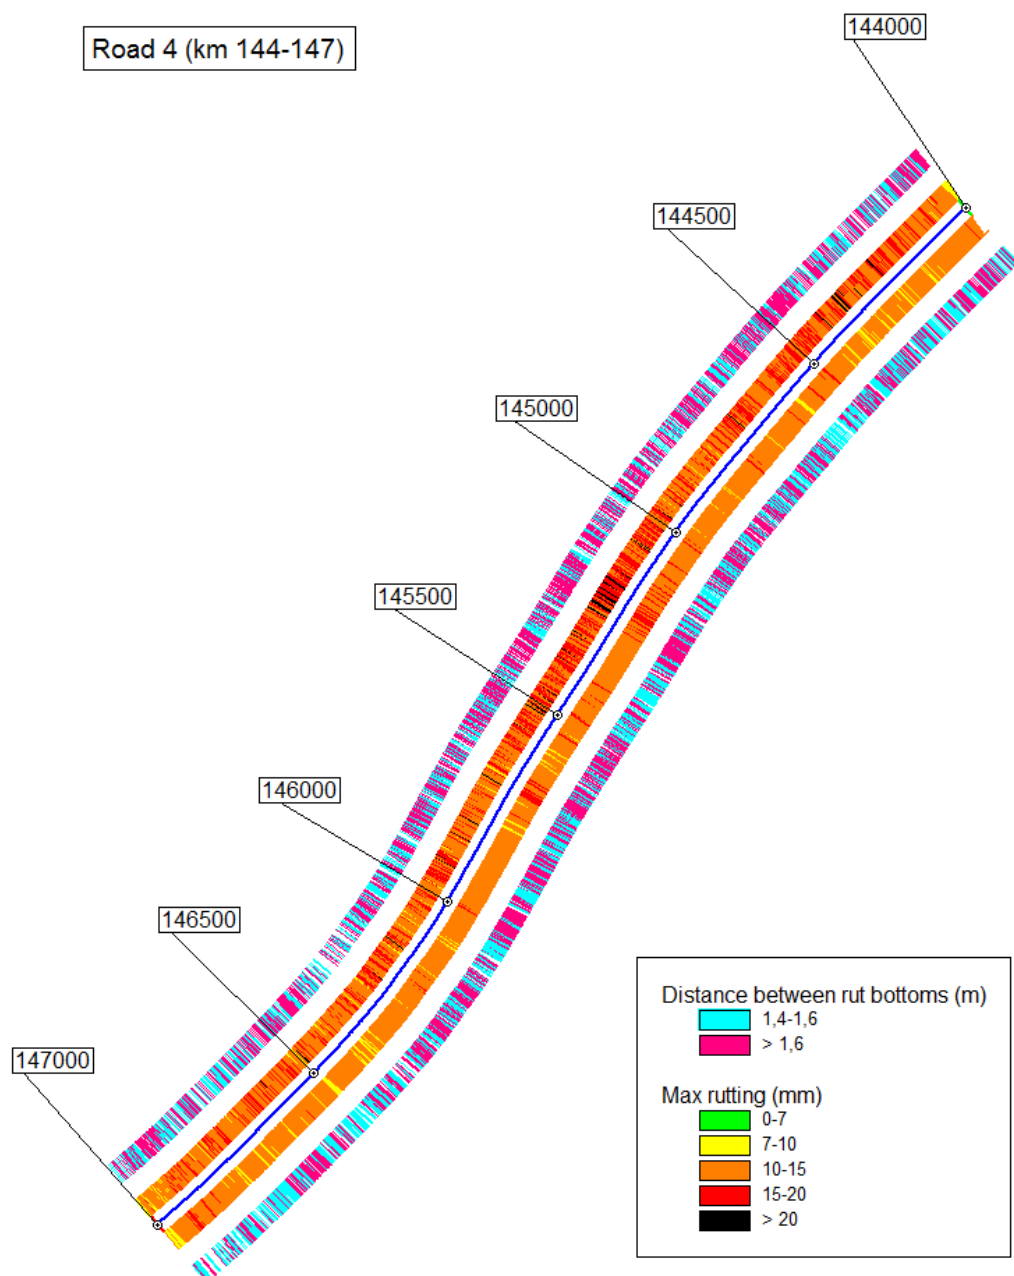
Rutting in the road section is mostly 10-15 mm. Lane 1 has slightly higher rutting than lane 2. In a few places in lane 1 rutting is over 20 mm and maximum rutting is about 26 mm (Table 68\_2 and Figure 68\_5).

Figure 68\_5. Maximum rutting on both lanes (inner lines, colours from green to black) together with distance between rut bottoms (outer lines, colours pink and blue).

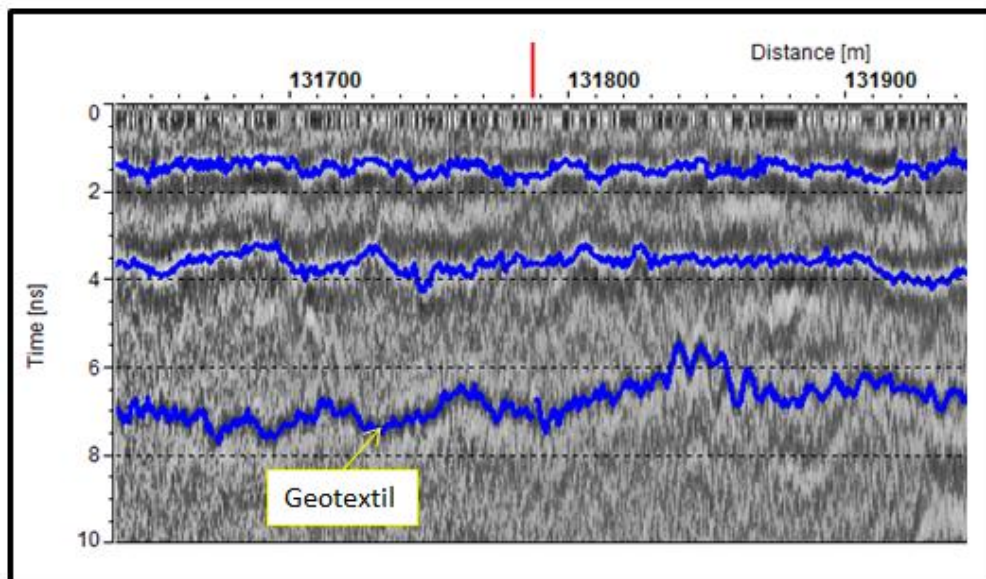
Geotextile is clearly seen at a depth about 40cm in the structure (Figure 69\_1). According to plan, geotextile has been placed as designed. The structure type change occurs at chainage 133640m (Figure 69\_2). According to the ground coupled GPR data the total thickness of road structure is quite variable (Figure 69\_3). During a close examination some strong reflections were observed in lane 1. These reflections are possibly moisture susceptible materials in the structure (Figure 69\_4).

Figure 69\_1. Geotextile at the depth of 40cm (about 7ns).

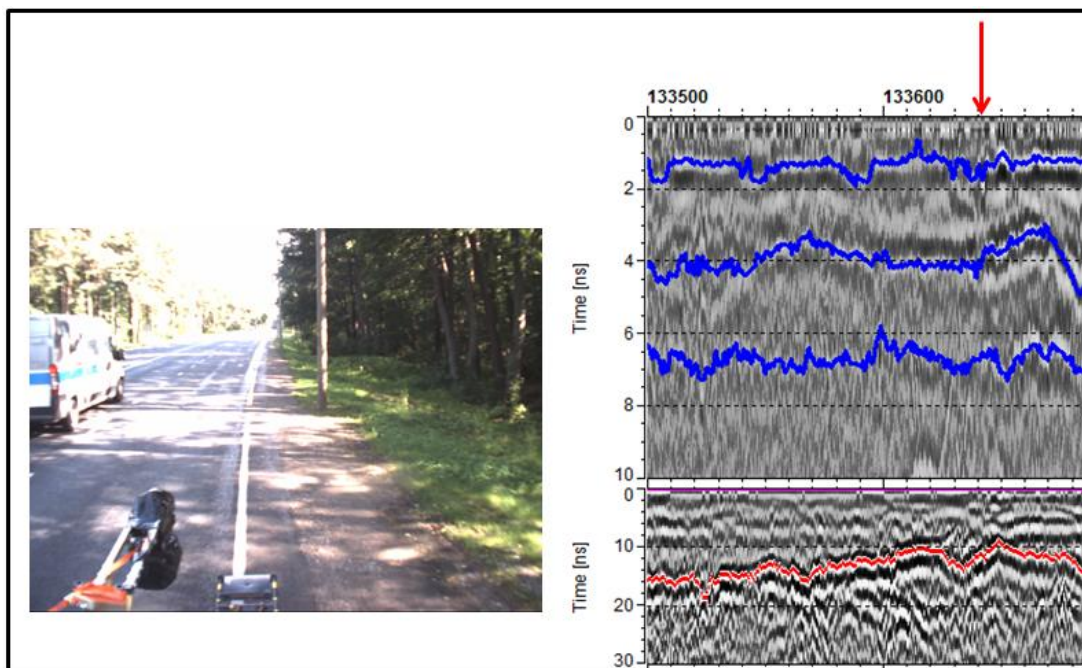
Figure 69\_2. A change in the structure type. The point of still image has been marked with red arrow.

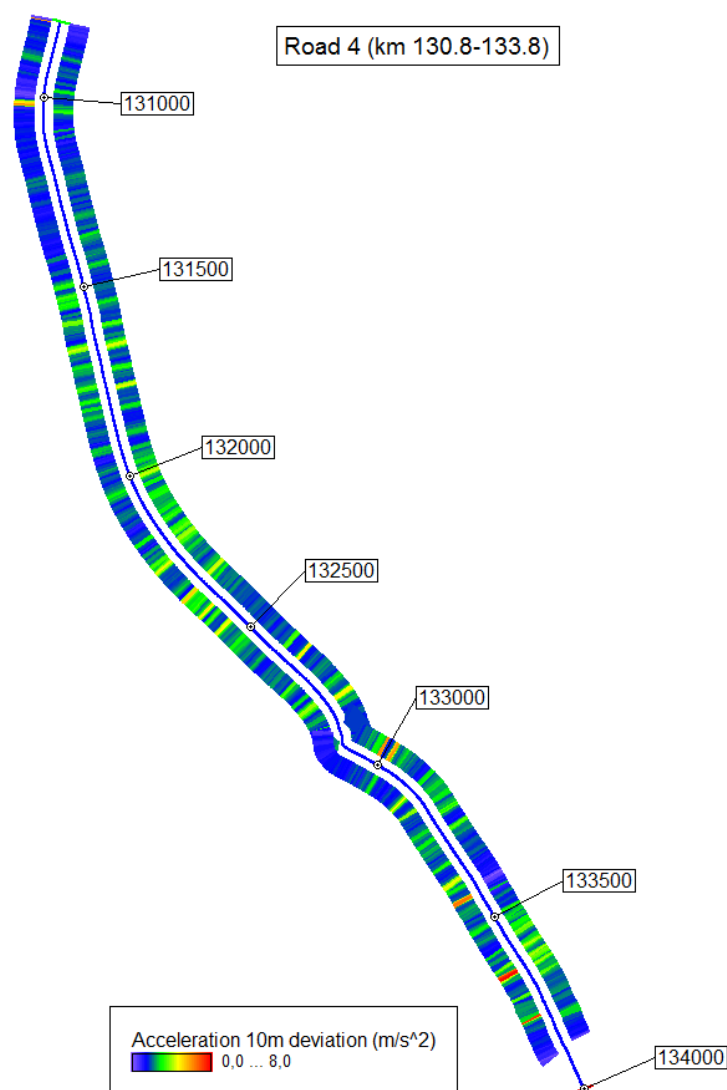
The pavement in this section is in good condition and the roughness in both lanes is quite low (Figure 69\_5). There were 3 traffic lights in the section (131 000 m, 132 870 m and 133 390 m) which affected the acceleration measurements in these places, because the survey car had to be stopped at some of them. In the beginning of the road section the pavement is new until 133 650 m. The largest acceleration spike at 133 650 m is caused by the pavement joint. Other acceleration spikes are caused mostly by road markings.

Figure 69\_5. Acceleration 10m deviation from section 9 presented as a map.

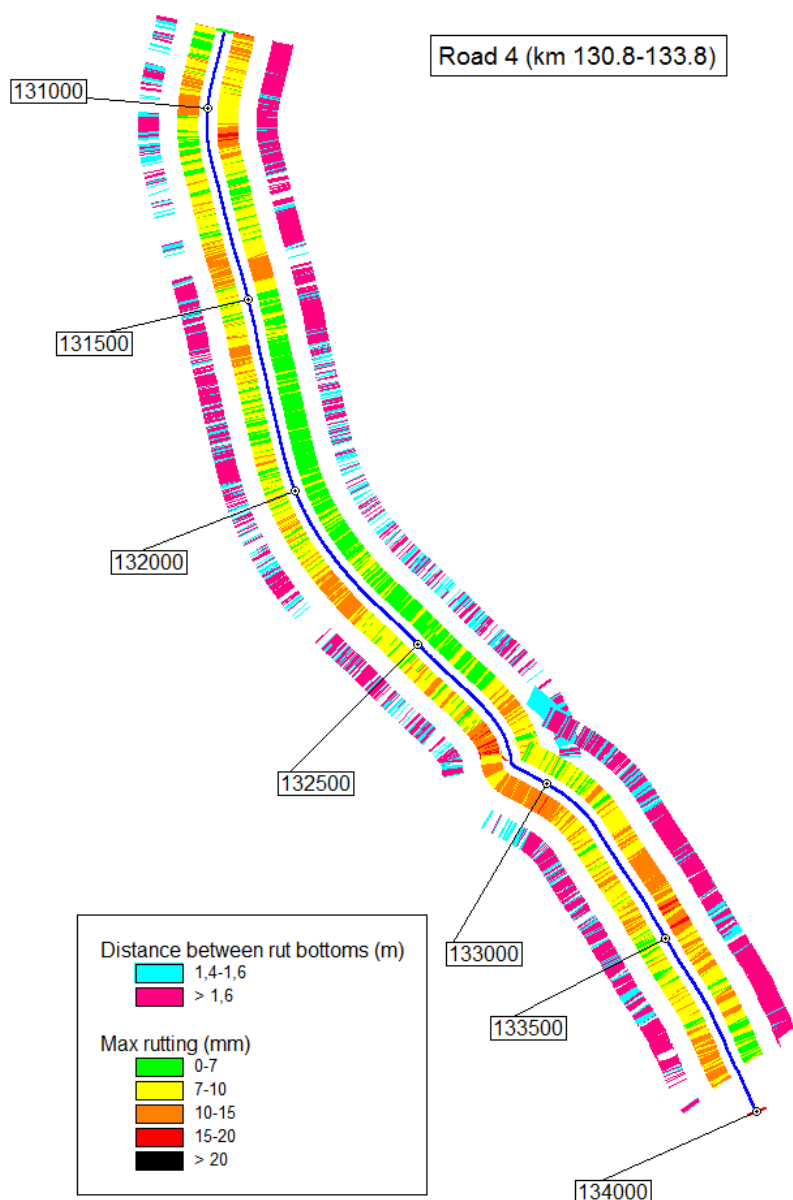
Rutting in the road section is low, because the pavement is new until 133 650 m. The most rutting is found at places where the cars have to stop for the traffic lights. Maximum rutting at these places is a little below 20 mm (Table 69\_2).

Figure 69\_6. Maximum rutting on both lanes (inner lines, colours from green to black) together with the distance between rut bottoms (outer lines, colours pink and blue).

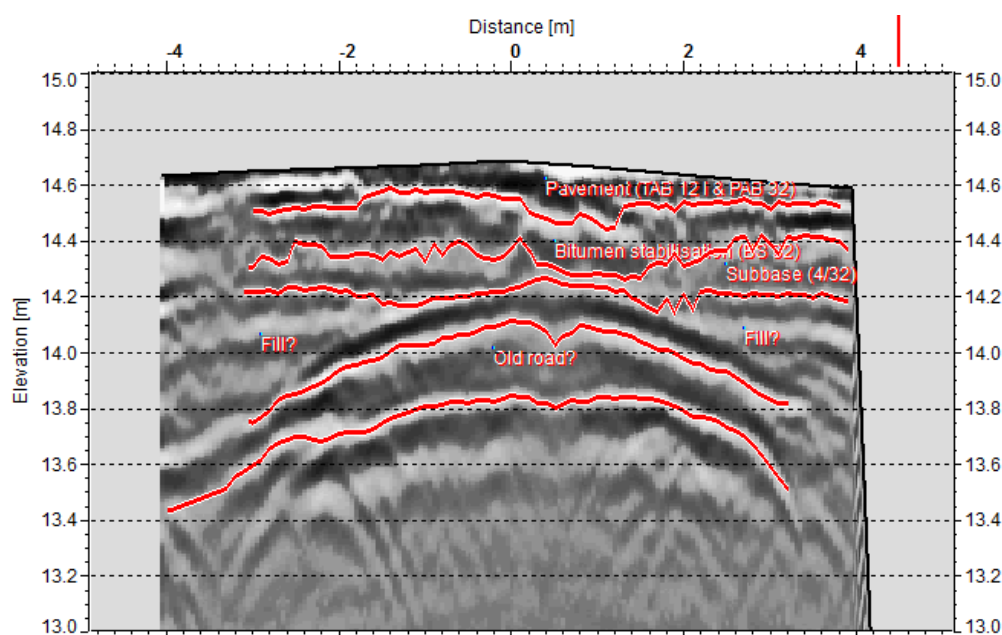
When comparing the design structure of section 10 to the Estonian design guidelines it can be stated that it fulfills the bearing capacity, rutting and roughness norms. Also designed thicknesses are according to the recommended (Table 610\_2), except base & subbase layer is too thin. In places the old road has been left into the structure (Figures 610\_1 and 610\_2).

The GPR cross section (measured at chainage 59km) confirms the observation that the old road has been left in the road structure in some sections (Figure 610\_1). Longitudinal GPR profiles also show that the bottom of road structures are at different depths in both lines in some places (Figure 610\_2). Probably the road has been widened. This might lead to differential frost heave problems later.

Figure 610\_1. GPR cross section from point 59km.

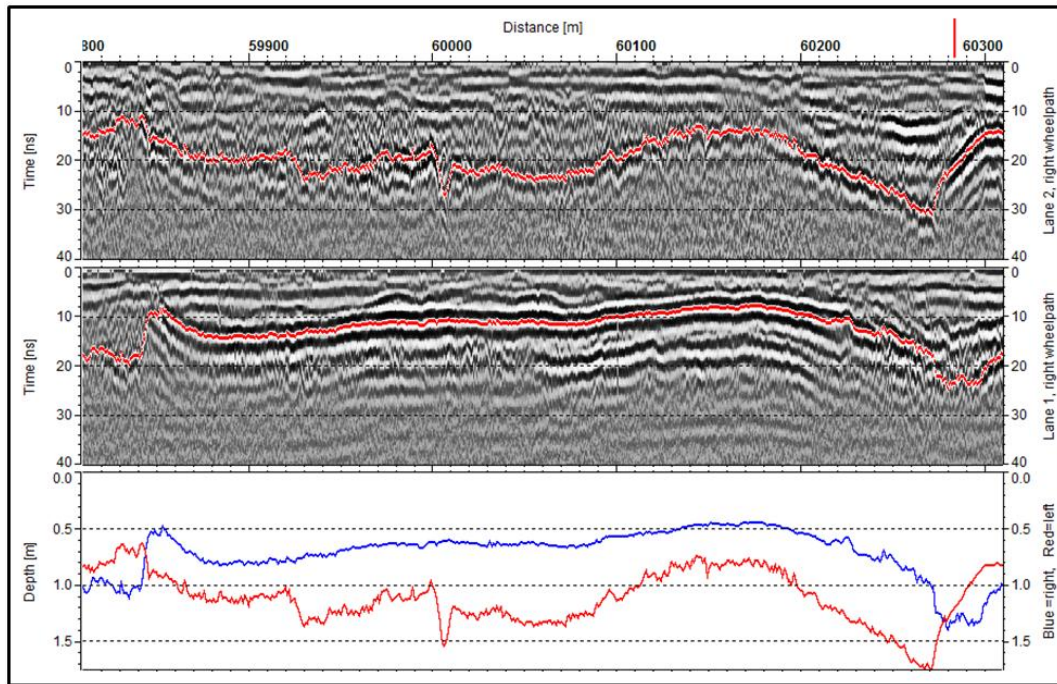
Figure 610\_2. GPR longitudinal profiles from Lane 2, right wheelpath (upper) and Lane 1, right wheelpath (lower). Lines in the lowest window represents the depth of road structure (blue = right, red = left).

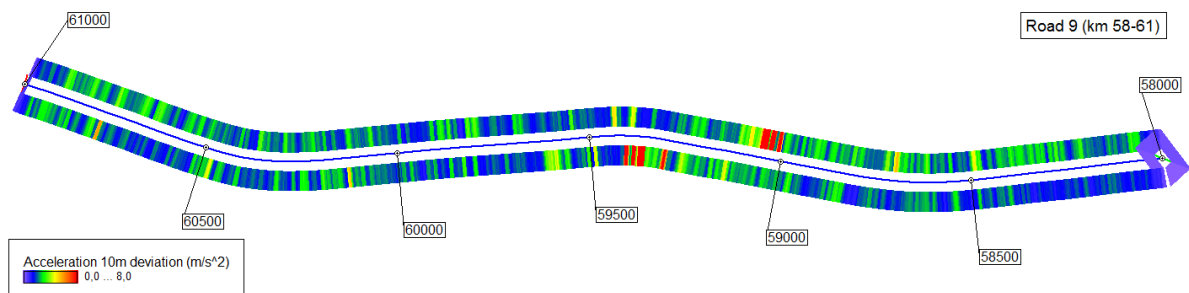
Generally the road surface is in good condition. It has been paved quite recently and there is no significant damage that could be seen in the accelerometer data. The higher acceleration spikes seen between 59 000m and 59 400m in the 10m acceleration deviation data are caused by speed bumps and pavement markings (Figure 610\_3 and 610\_4).

Figure 610\_3: Acceleration 10m deviation from section 10 presented as a map.

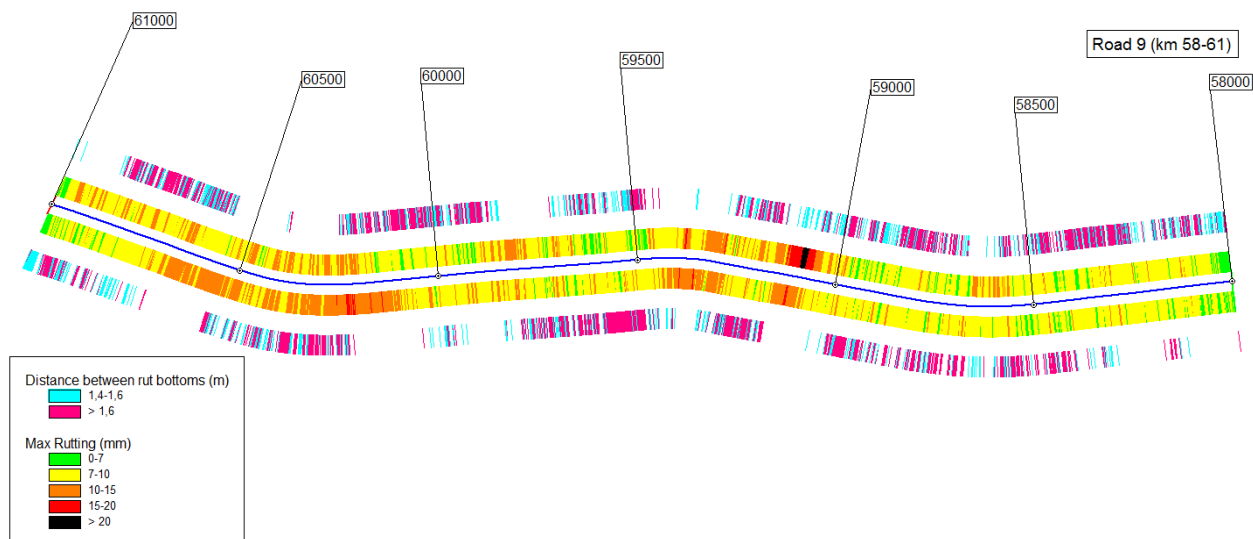
Rutting on the road section is low. Average rutting is between 7-9 mm (Table 610\_2). The highest rutting values are located near the crossroads (59 100 m and 59 300 m) and can be partly caused by the crossroad paintings (Figure 610\_5).

*Figure 610\_5. Maximum rutting in both lanes (inner lines, colours from green to black) together with distance between rut bottoms (outer lines, colours pink and blue).*

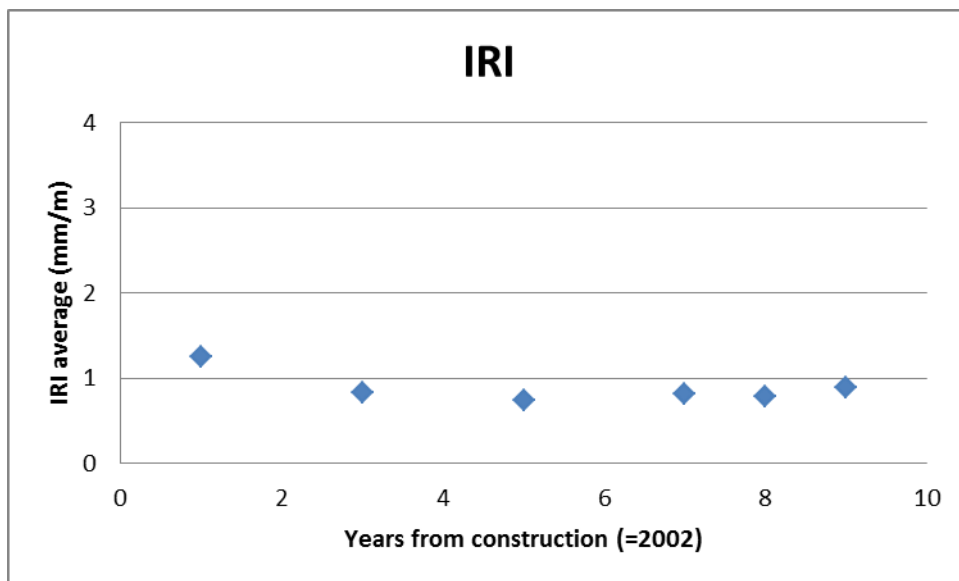
The roughness and rutting values (provided by Riigikontroll) were examined statistically. It can be said that roughness values were at quite low level. In average they were at the level of 1 mm/m and no linear increasing was detected. This means that values are below the critical limit (chapter 5.5.2 Roughness performance). Figure 77\_1 presents an example of IRI values from road section 6 and Figure 77\_3 from road section 8.

Figure 77\_1. IRI values from road section 6 (road 2, km 150-153).

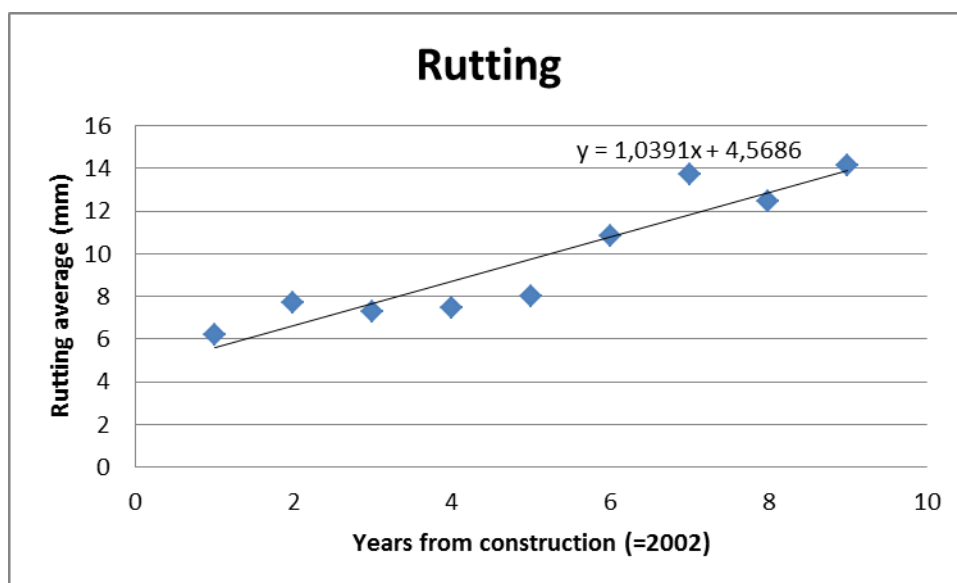
Statistical analysis was also made from rutting values. Some sections like section 3 and section 5 had had rut repairs and patching made after construction, which affect the measured rutting values. Figure 77\_2 presents rutting values and their growth rate from road section 6, which had one of the highest rut increase rates of the surveyed sections. Rutting growth rate is on this section about 1 mm/year. Figure 77\_4 presents rutting values from road section 8, which was built at the same time as

Figure 77\_2. Rutting values from road section 6 (road 2, km 150-153).

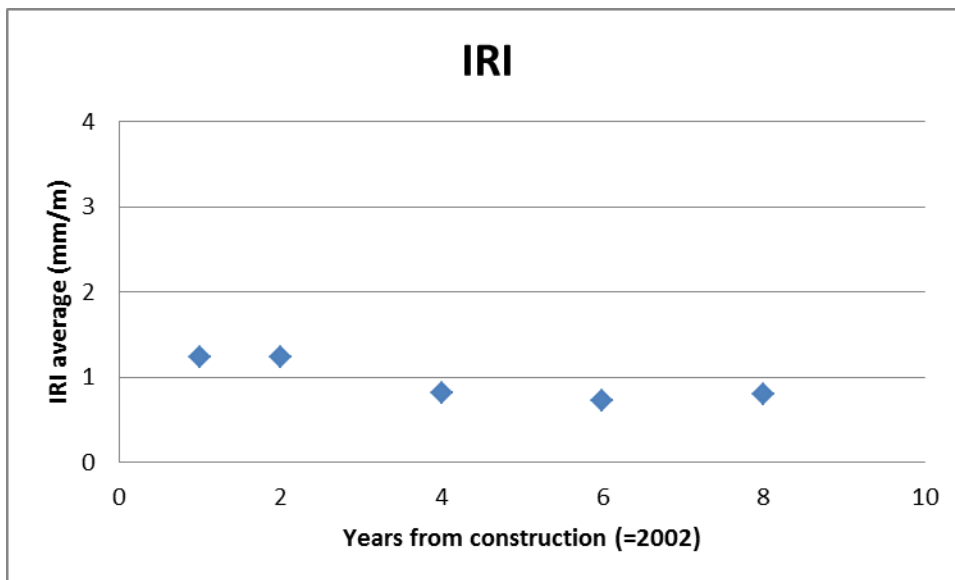
Figure 77\_3. IRI values from road section 8 (road 4, km 144-147).

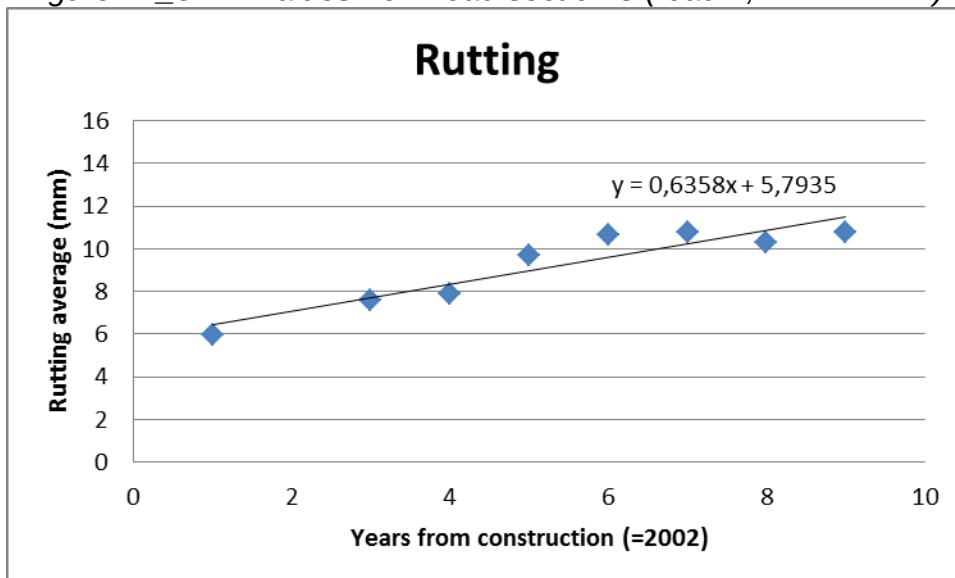
road section 6, but has lower rut increase rate (about 0,6 mm/year). Measured rutting from 2011 was on the road sections mostly below the critical limit 20 mm, only a few measured 100 m average values were 20 mm or over.

Figure 77\_4. Rutting values from road section 8 (road 4, km 144-147).
