# ROADSCANNERS

# Principles of Drainage Classification

# VISUAL DRAINAGE CONDITION CLASSIFICATION OF PAVED ROADS

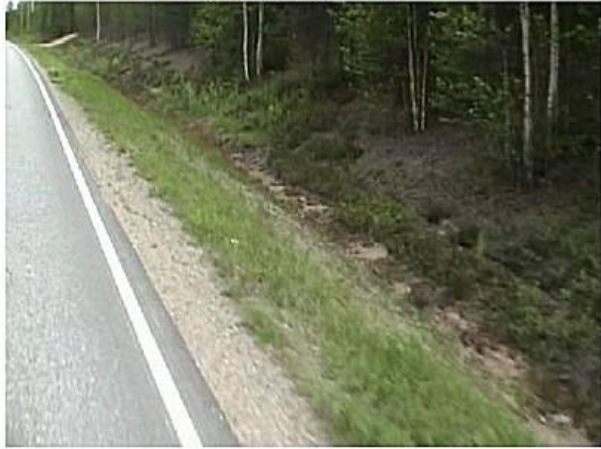
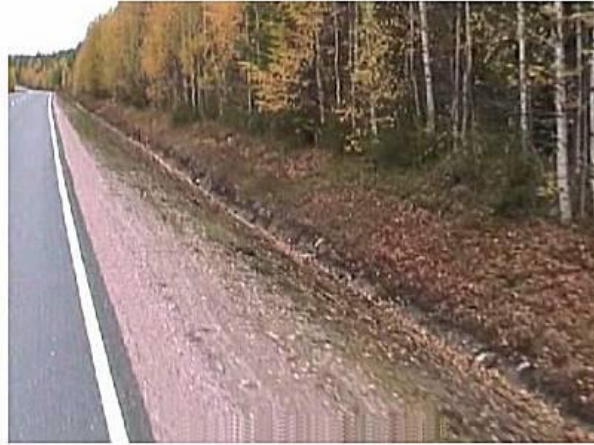
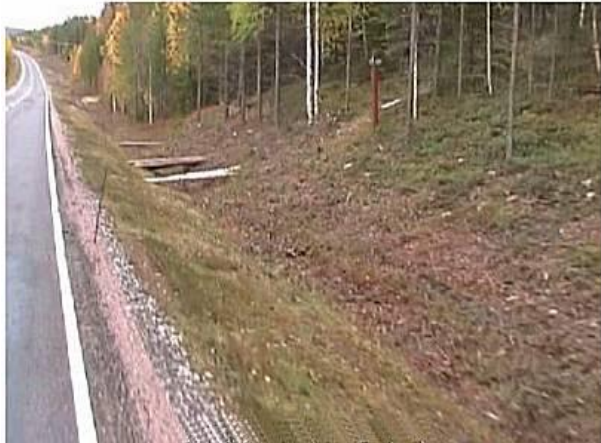
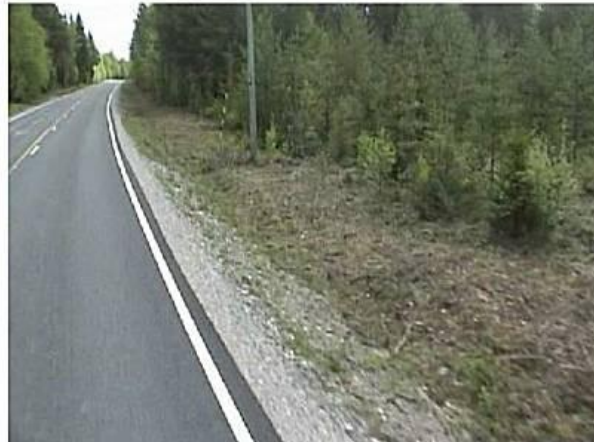
## Class 1: Good Drainage Condition

Faultless drainage. Road cross section shape has preserved its form well and water flow from the pavement to ditch has no obstacles. Unrestricted water flow in ditches.

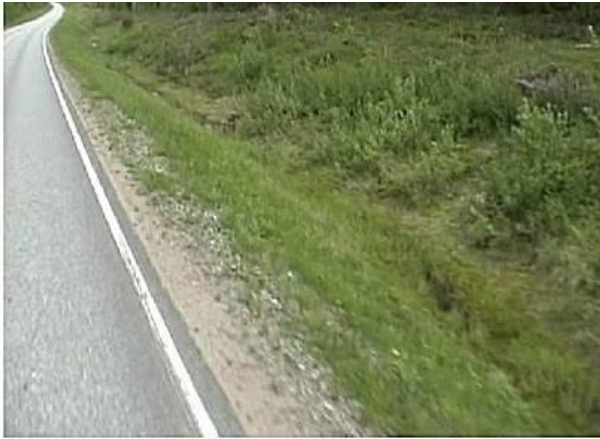
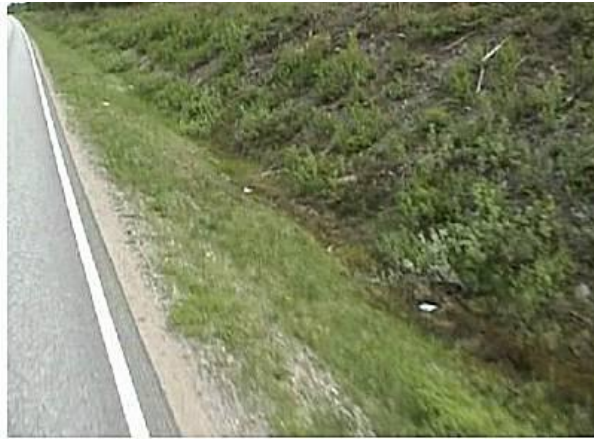
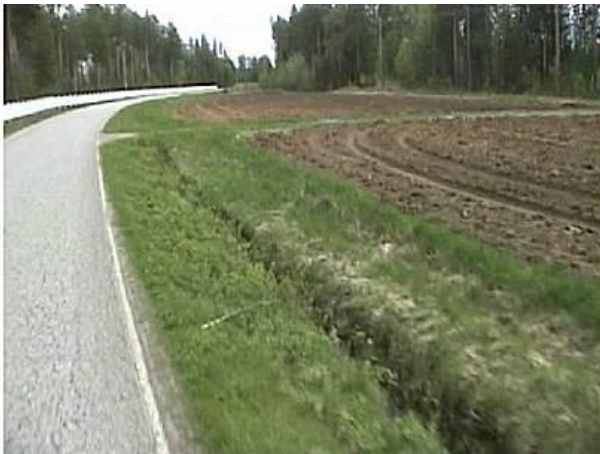
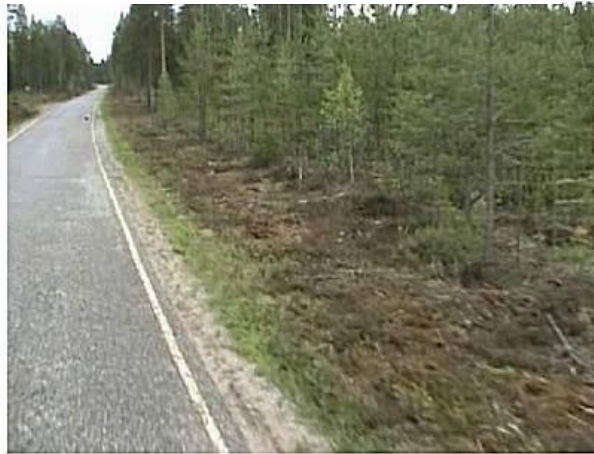
## Class 2: Adequate Drainage Condition

Small changes in the road cross section form can appear. Road shoulder has small verges or vegetation that prevents good water flow to ditch. Vegetation in ditch restrains water flow and causes dams. Small amount of soil flows from road slopes into ditches and raises the bottom of the ditch, slows the water flow and raises the ground water table.

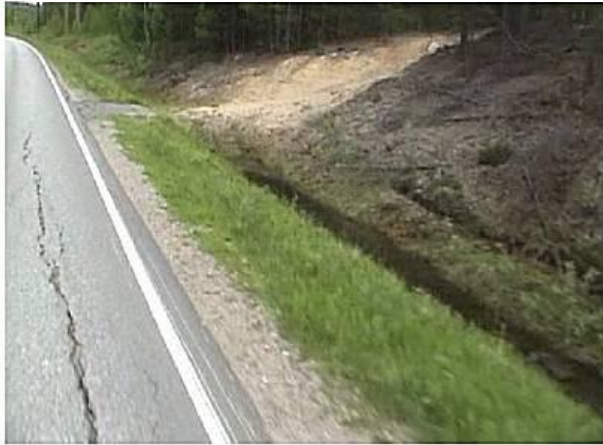
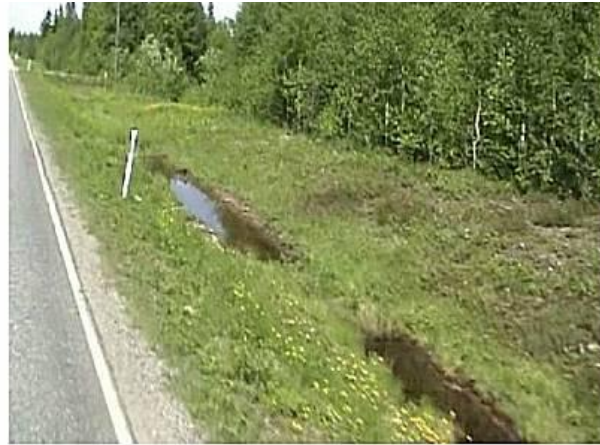
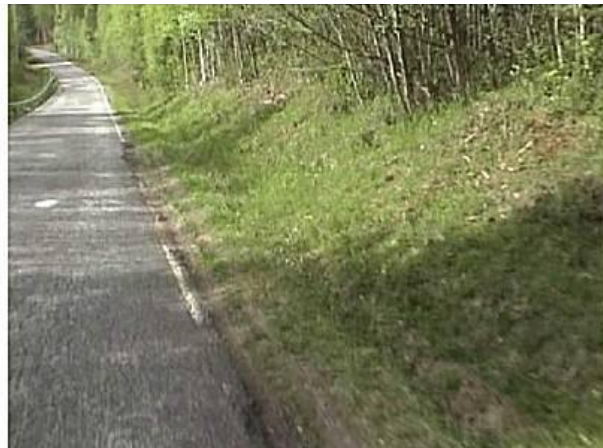
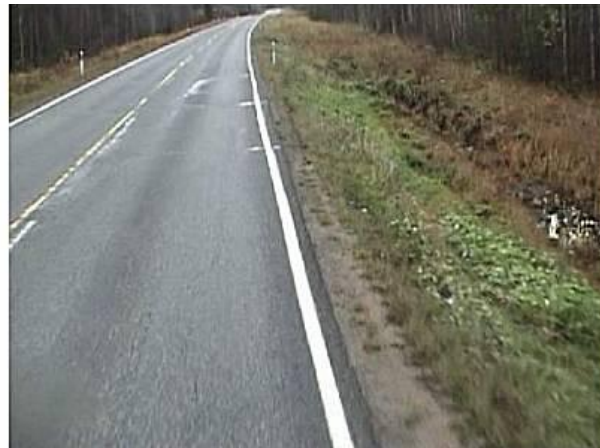
## Class 3: Poor Drainage Condition

Deformations and damages in the road cross section. Road shoulder can have a high verge and/or dense vegetation that causes ponding on the traffic lane or on the shoulder. Vegetation in ditch restrains water flow and causes dams in the ditch. Unstable soil flows from ditch slopes into ditches and blocks the water flow. Clocked culvert or outlet dict prevent the water flow in the ditch.
